Geotechnical Report

GEOTECHNICAL INVESTIGATION REPORT
FOR
PROPOSED RESIDENTIAL DEVELOPMENT,
131 AND 189 THREE MILE BUSH ROAD, KAMO, WHANGAREI

Project Reference: 18733
24 June 2021

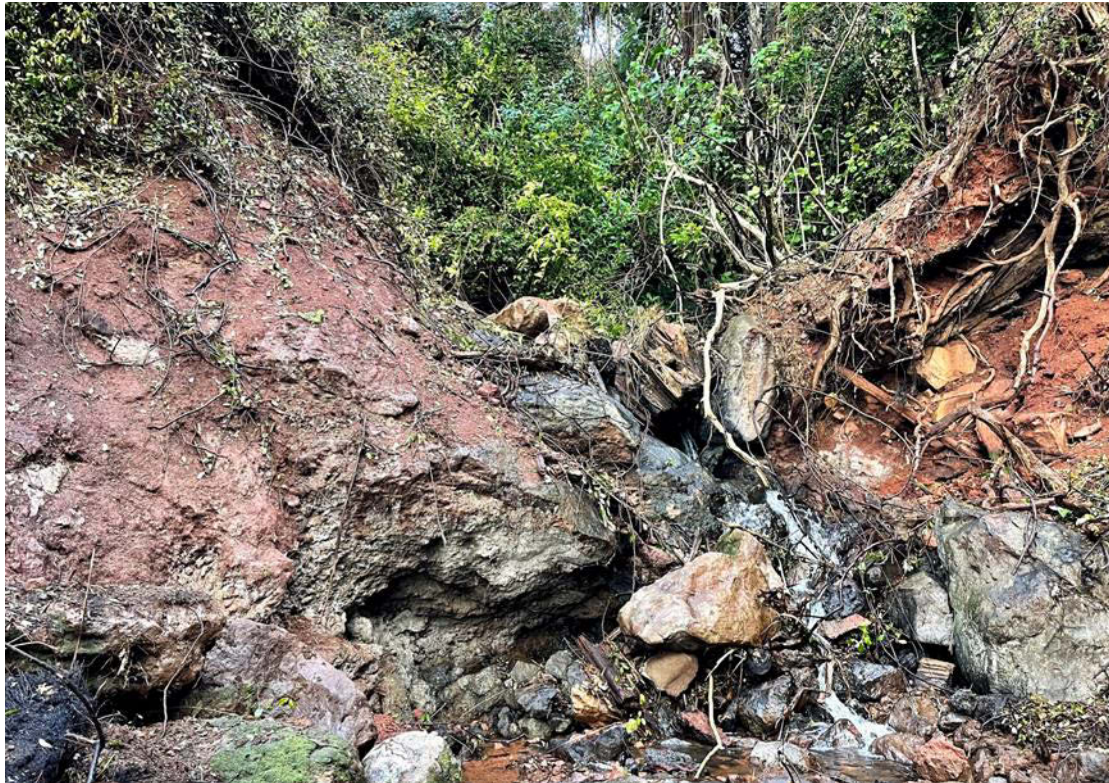
The gully side slopes are very steep around the head at approximately 1V:1.5H (34°) and generally 1V:2H (27°) beyond this. The gully slopes present no signs of significant active or recent instability, and it appears from the topography of the feature that it has been formed through steady erosion rather than periodic regression through instability. However, some evidence of shallow creep type movement was noted on the southern side of the gully, where the fence appears to have been gradually undermined.

Several exposures of large basalt boulders are noted around the crest at the western end of the gully. Several areas of tephra soils are exposures through the mid-section of the steeper slopes. The gully floor is covered by cobble to boulder sizes clasts of loose basalt, with some possibly in situ basalt at the base of the gully head.

Figure 3: View west from the gully floor towards the gully head, showing basalt exposed beneath red tephra soils at the base of the gully slopes.

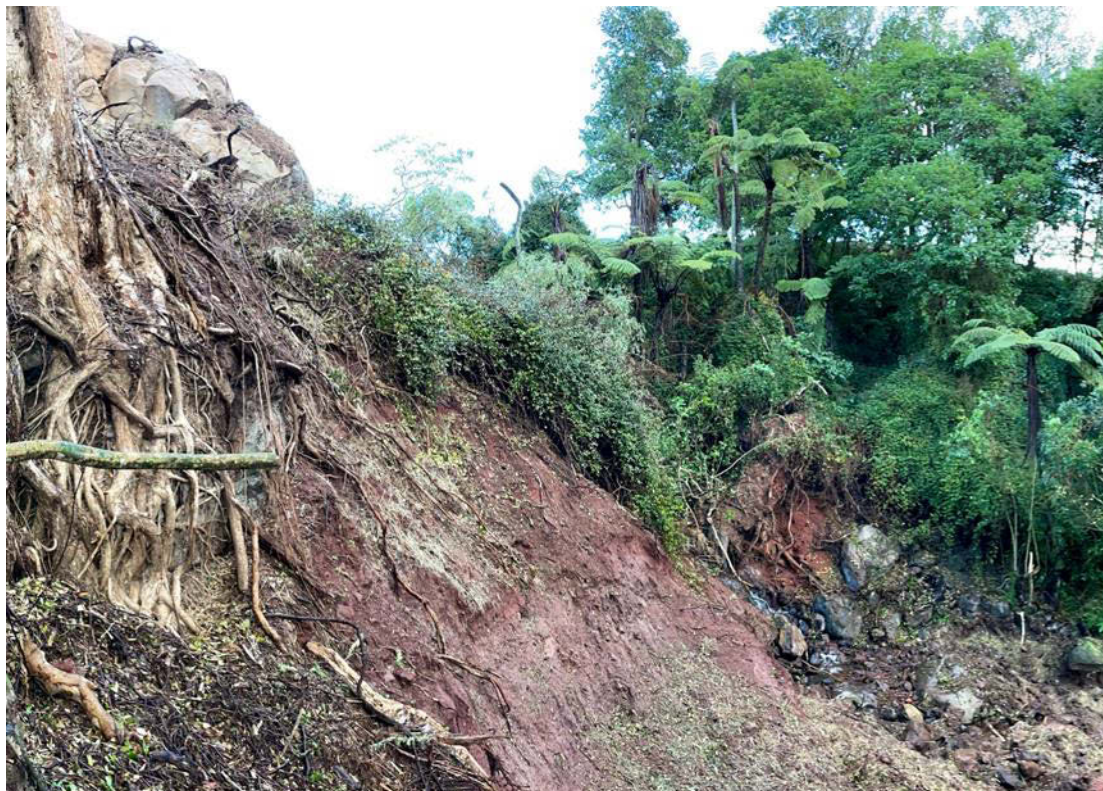
Figure 4: View west across the southern gully slope, showing large basalt promontory at crest of slope (top left), tephra soils immediately below, and boulders of basalt over the gully floor.

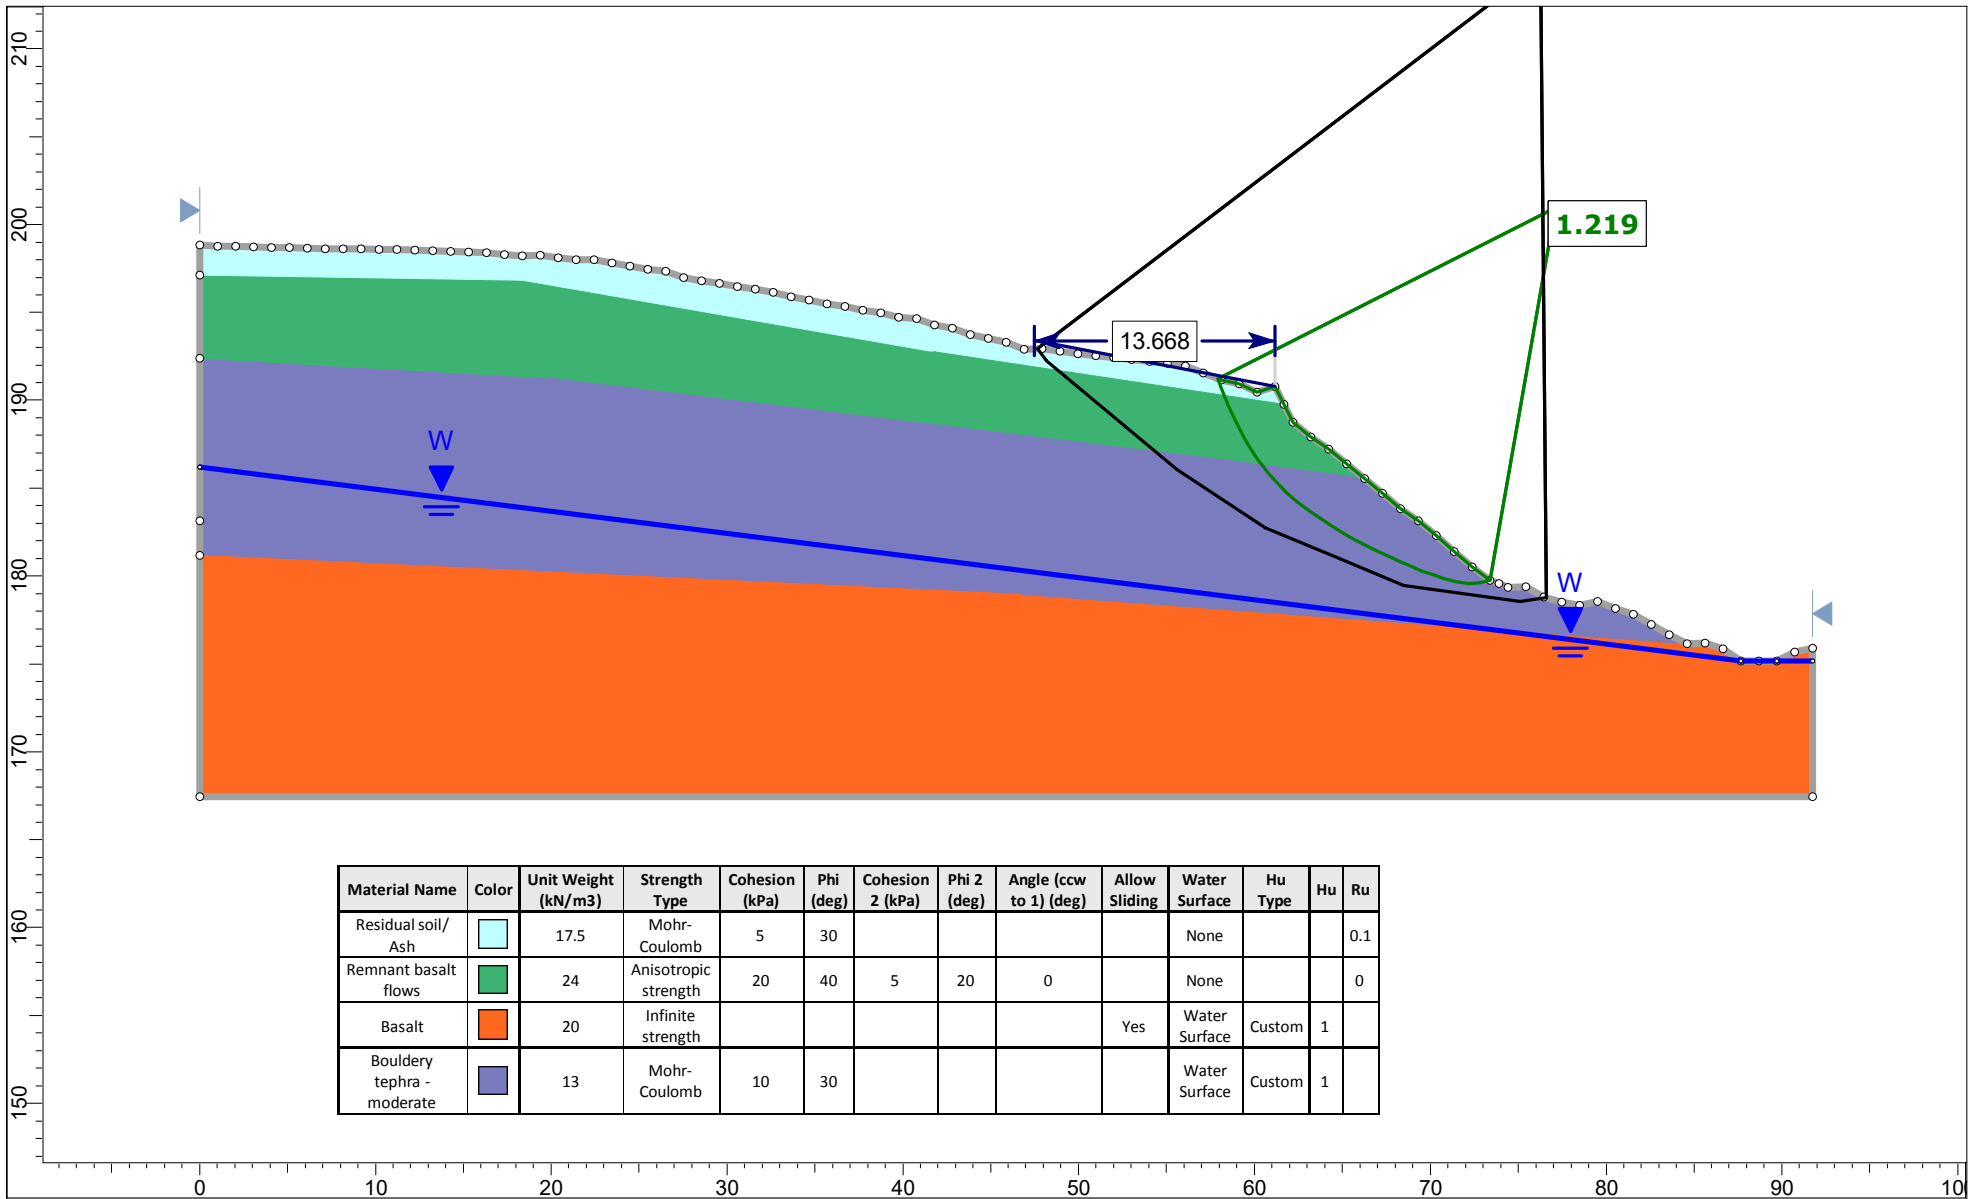
Project		131 and 189 Three Mile Bush Road	
Analysis Description		CS-2 - Design conditions	
Drawn By	FWH	Scale	1:430
		Company	LDE Ltd
Date	22/06/2021	File Name	18733.slmd

To assess the stability hazard of the gully feature, numerical slope stability analysis has been carried out for a critical side slope section (CS-2), on the southern side of the gully head. Back analysis was used to calibrate modelled groundwater conditions and material strength parameters, using an assumed minimum factor of safety of just above 1.0 under extreme conditions.

Scenario	Minimum FoS ³	Setback required
Normal (design conditions)	1.5	14m
Extreme groundwater	1.3	8m
Seismic (500-year/ULS)	1.1	10m
