PRELIMINARY SITE INVESTIGATION
RUAKAKA SERVICE CENTRE
RUAKAKA

Reference: FES 1359.001 March 2020

Project Name Preliminary Site Investigation

Ruakaka Service Centre, Ruakaka

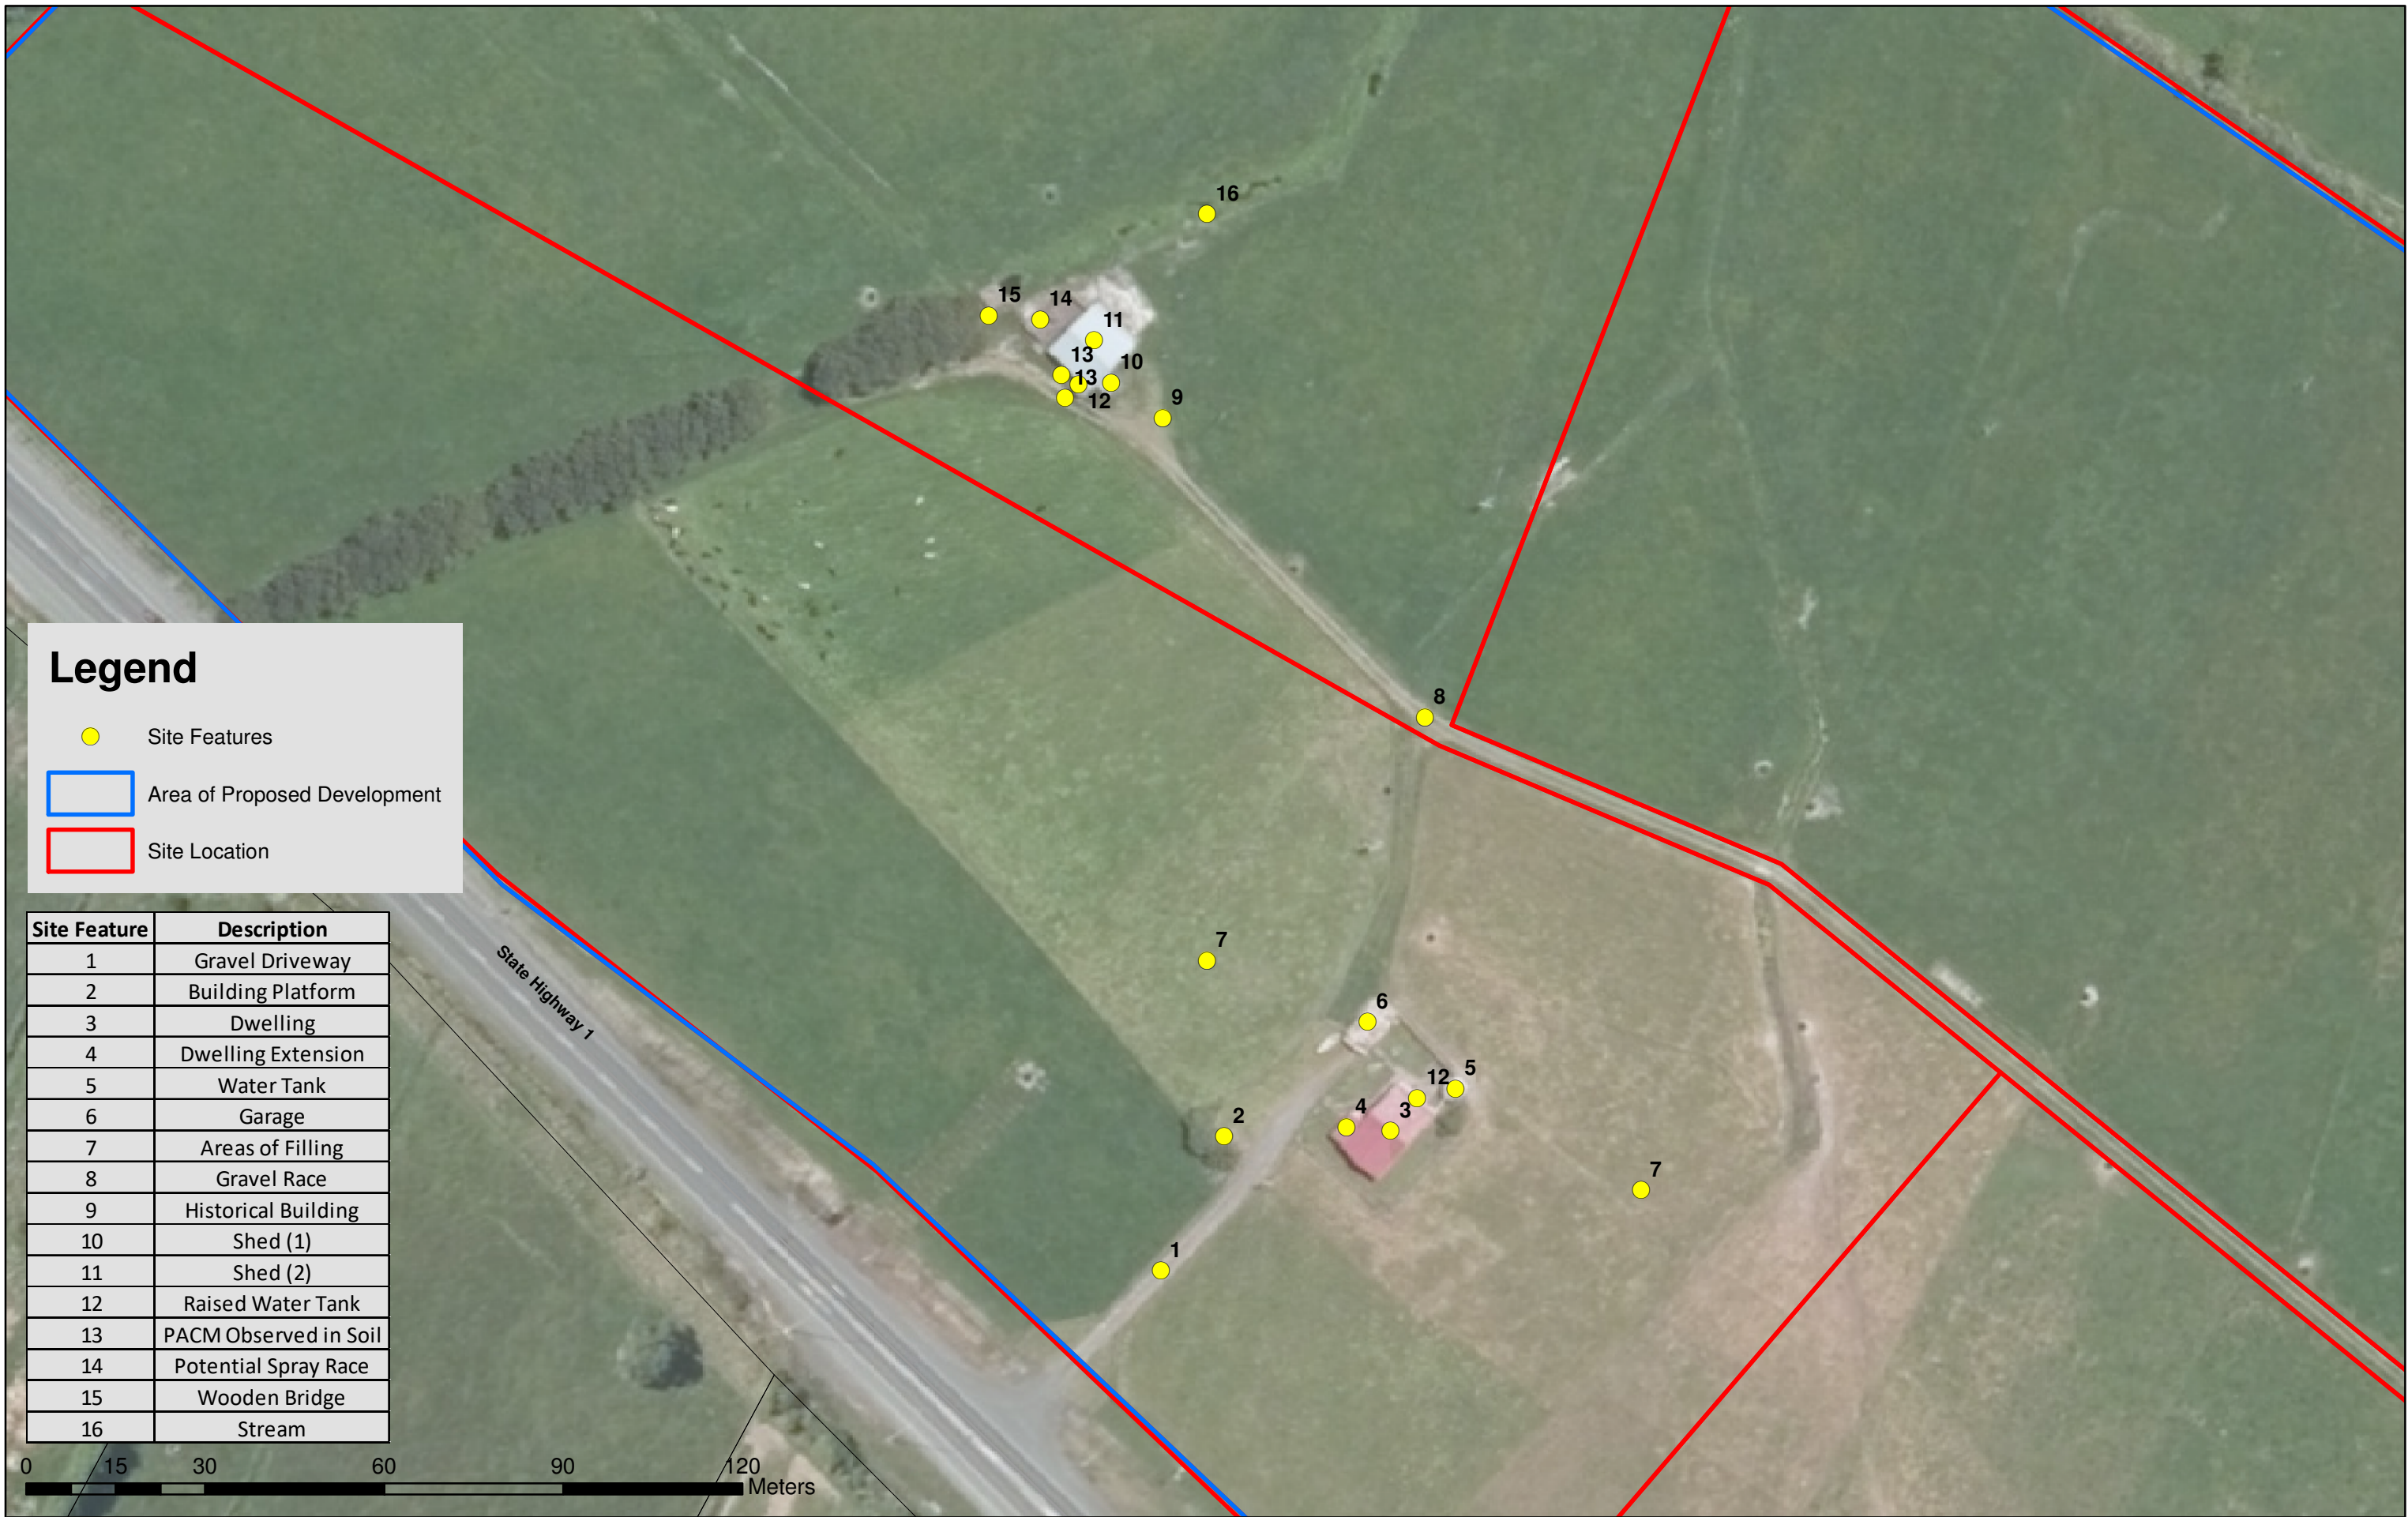
Drawing Number: 1359.001.02
Drawn By: PS
Checked By: DO'R
Date: 11/03/2020

Figure 2 - Site Features Plan

Site Feature	Description
1	Gravel Driveway
2	Building Platform
3	Dwelling
4	Dwelling Extension
5	Water Tank
6	Garage
7	Areas of Filling
8	Gravel Race
9	Historical Building
10	Shed (1)
11	Shed (2)
12	Raised Water Tank
13	PACM Observed in Soil
14	Potential Spray Race
15	Wooden Bridge
16	Stream

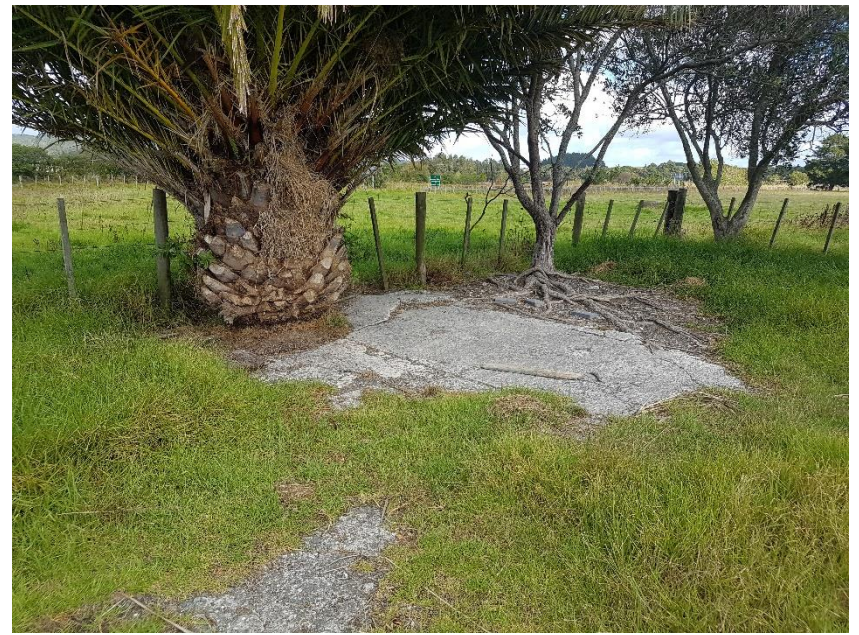
The small concrete building platform from a potential historical building was situated to the west of the driveway. Bricks were present in the vicinity of the building platform but no visual or olfactory evidence of contamination was observed.

Concrete Building Platform

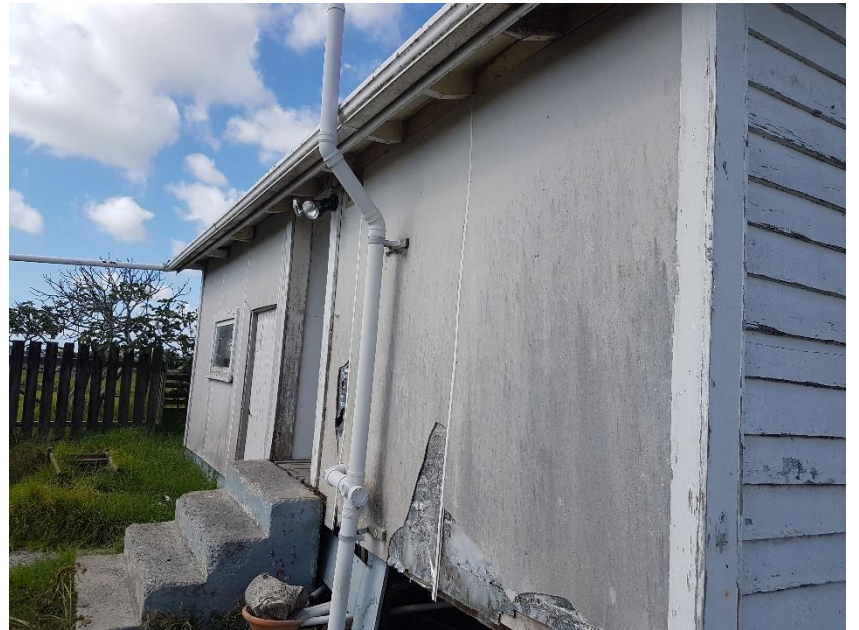
The single storey dwelling was constructed of painted weatherboard on the southern, eastern and western sides and Potentially Asbestos Containing Material (PACM) cladding on the northern side. The PACM was in a deteriorated condition with some fragments visible within the soil profile. The soffits appeared to be constructed of wood and the roof was made of iron. An extension to the dwelling was observed on the western extent of the dwelling and was constructed of painted PACM cladding which appeared in good condition.

PACM Cladding on Dwelling

Prior to the development of the site, a detailed site investigation is recommended. The detailed site investigation would confirm if the identified land uses and/or activities have affected the site soils and will confirm the consenting requirements for these areas of the site.

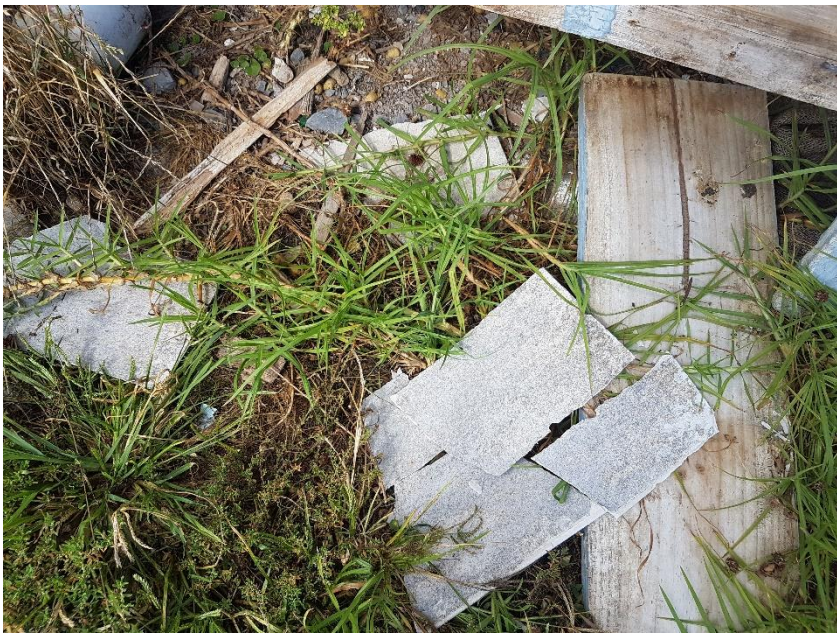
During the site walkover and inspection, PACM fragments were observed in the soil profile surrounding the dwelling and the two sheds. Additionally, two potential historical buildings and a potential spray race were also identified at the site.

PACM in Soil Adjacent to Dwelling

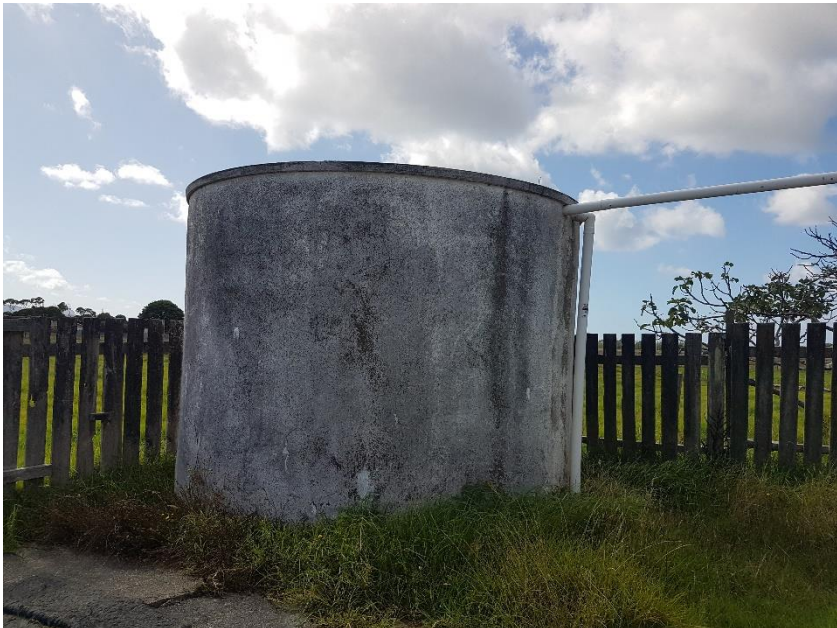
A concrete water tank was observed to the north of the dwelling. No visual or olfactory signs of contamination were observed around the water tank.

Concrete Water Tank

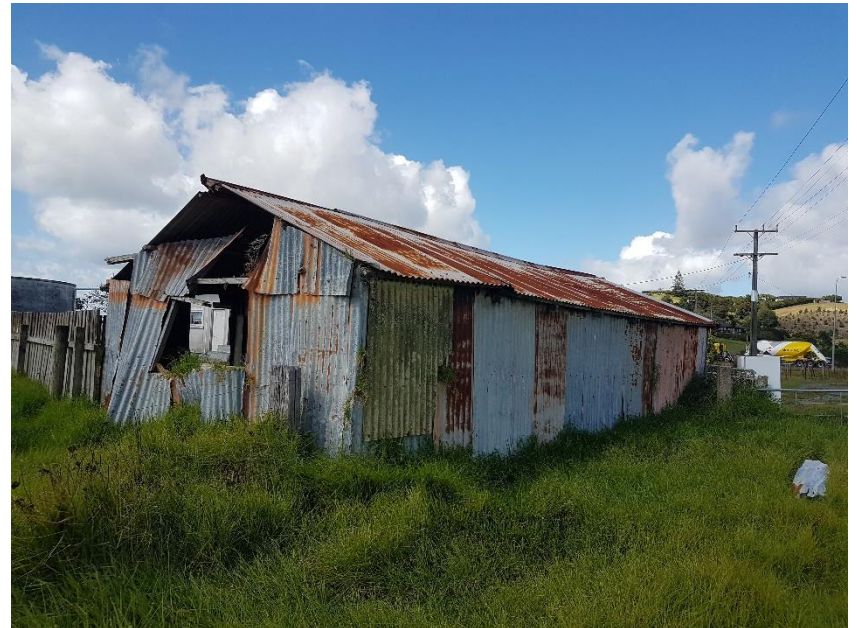
An unpainted tin garage was located to the north of the dwelling. The shed was concrete lined and in use for general household storage. A single panel of corrugated PACM cladding was observed on the western extent of the garage and appeared in good condition. No visual or olfactory evidence of contamination was observed in or around the garage.

Tin Garage with Single PACM Panel

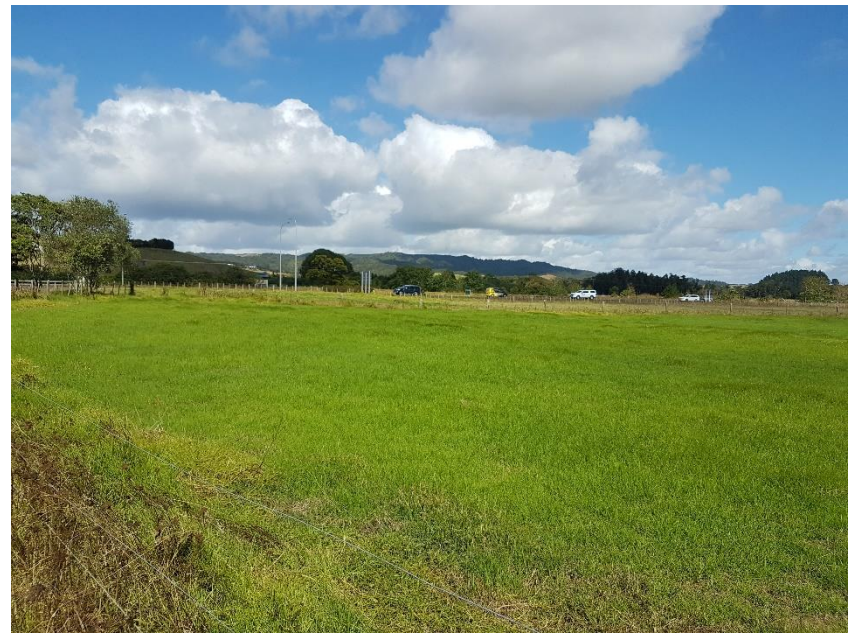
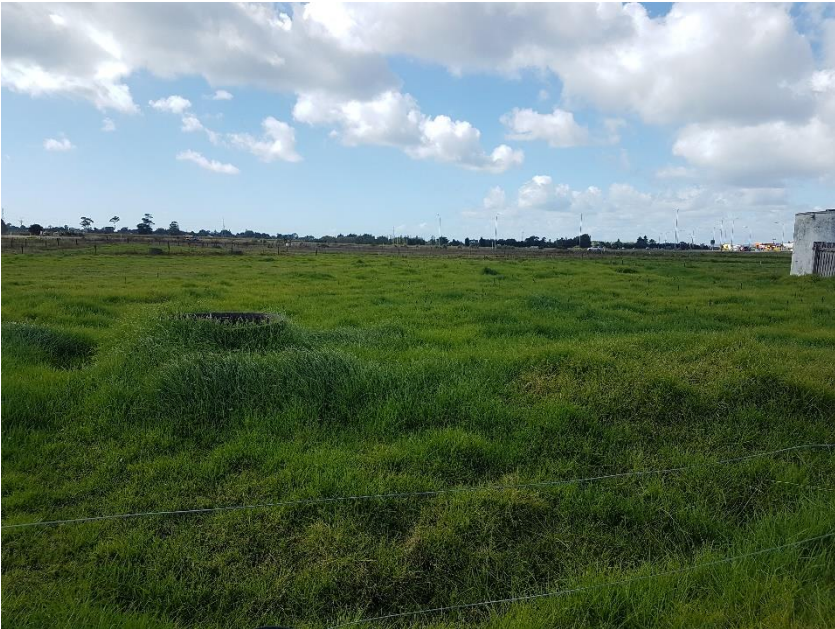
Areas of filling were identified in the pastures surrounding the dwelling, garage and building platform. No visual evidence of contamination was observed within the areas of filling.

Area of Filling

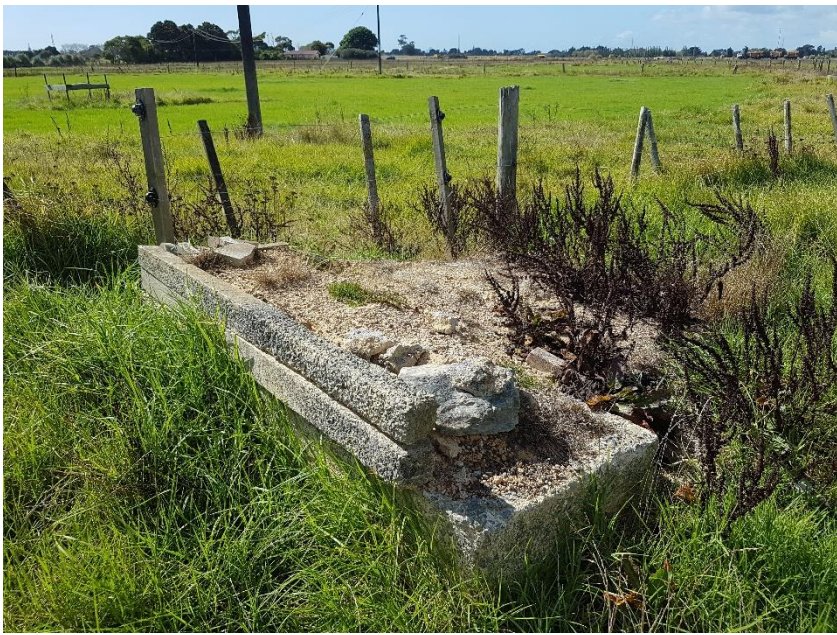
A potential historical building was observed to the north of the race. The historical building consisted of a concrete and cinderblock base with hardstand observed within it. No visual evidence of contamination was observed around this area.

Historical Building

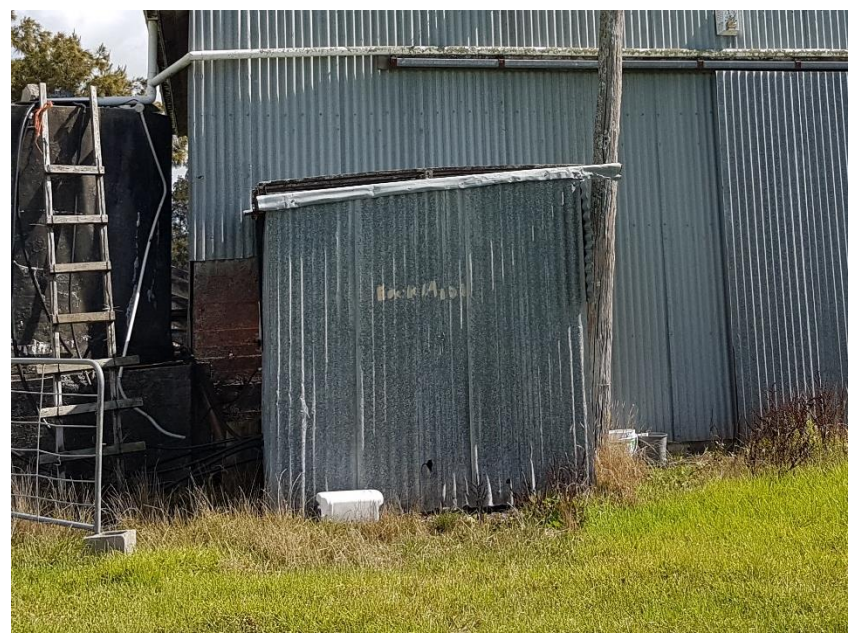
Shed (1) constructed of unpainted metal was situated in the western portion of the site. The shed was locked, unlined and appeared in use as a pump shed. No visual evidence of contamination was observed around shed (1).

Shed (1)

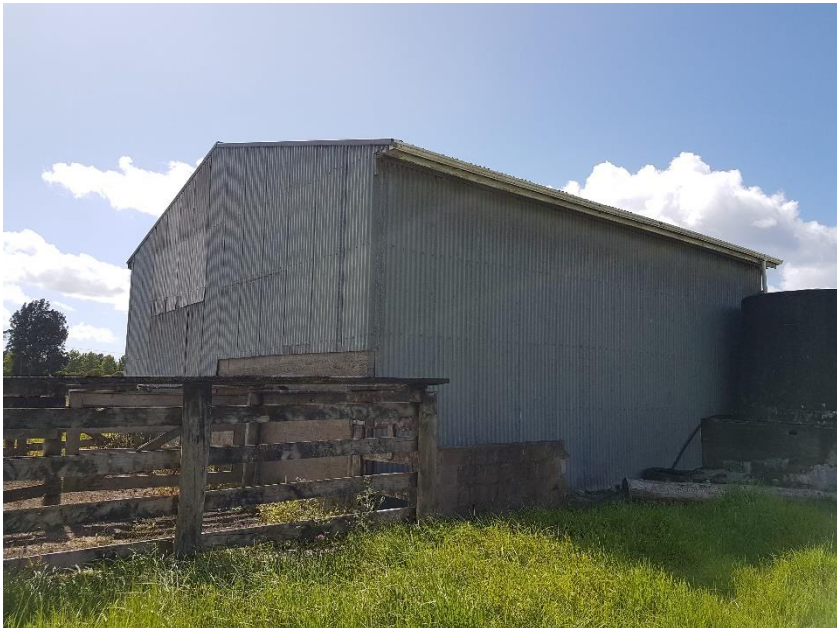
Shed (2) was adjacent to shed (1) and was constructed of unpainted tin. The shed was concrete lined and in use for hay storage. No visual evidence of contamination was observed within shed (2).

Shed (2)

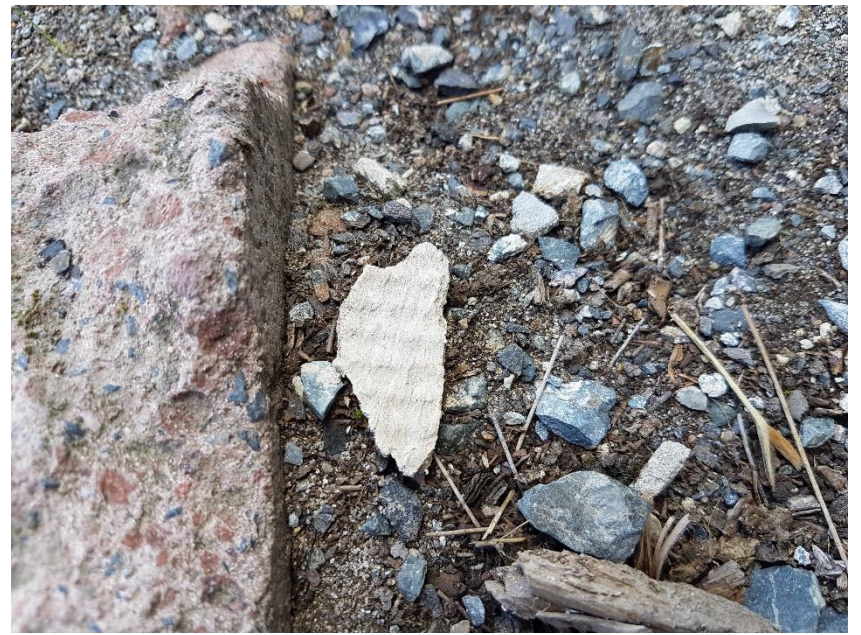
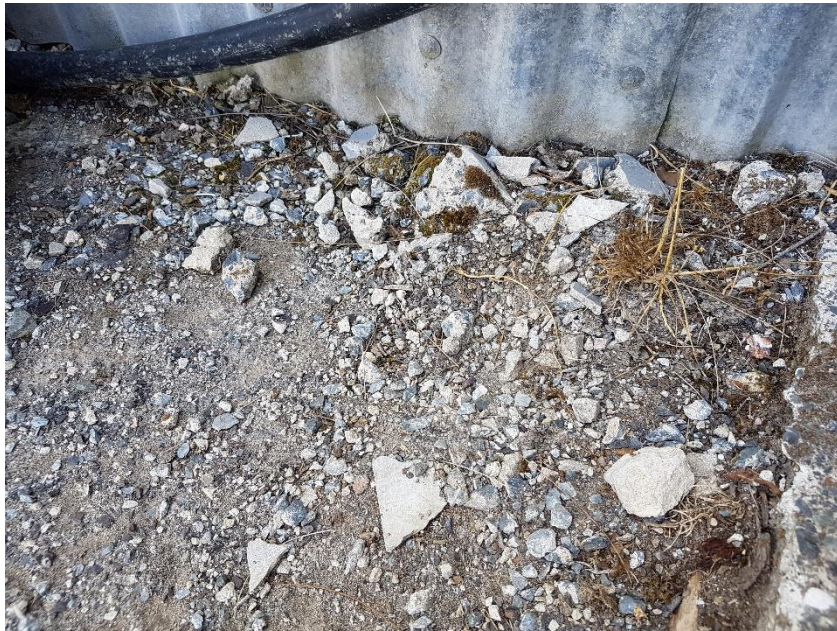
A concrete water tank on a raised concrete platform was observed adjoining the southern extent of shed (2). Visible fragments of PACM was observed within the soil profile surrounding the concrete platform.

PACM in Soil Around Raised Water Tank

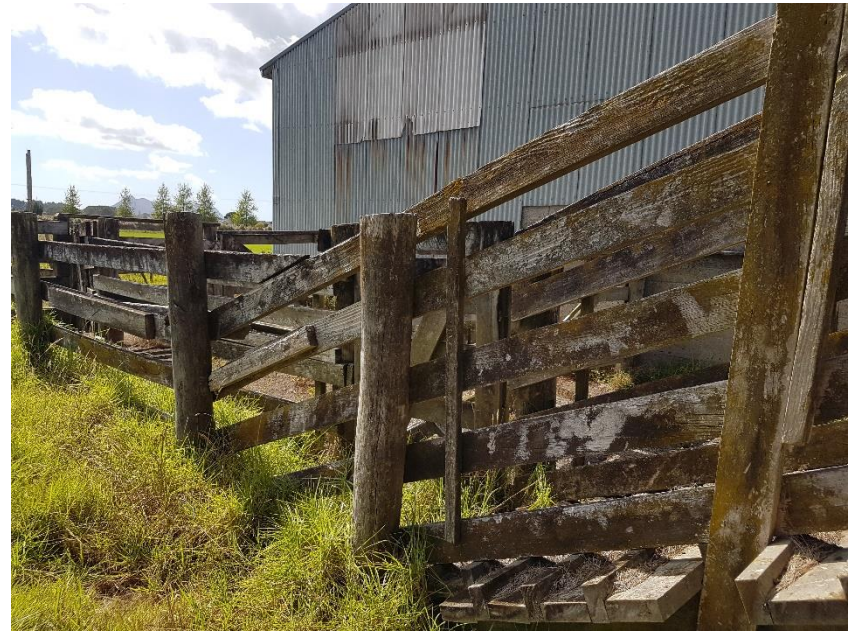
To the west of shed (2), a potential spray race, stock loading ramp and concreted stock yard was observed. No visual or olfactory evidence of contamination was observed within this area of the site.

Potential Spray Race

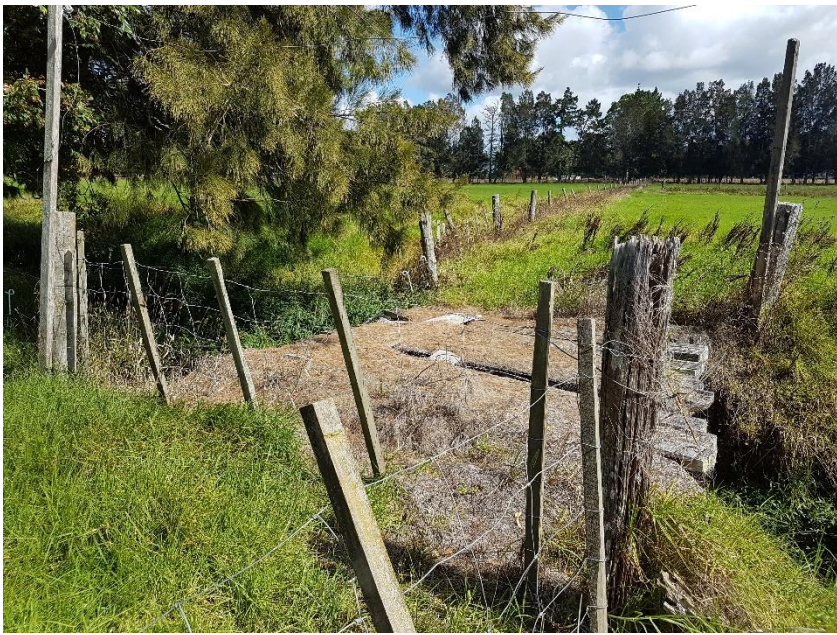
A stream was located to the west of the utility buildings and was overgrown with vegetation. A wooden bridge across the stream was also observed. No visual evidence of contamination was observed in or around the stream.

Wooden Bridge
