***DETAILED SITE INVESTIGATION  
REMEDIACTION ACTION PLAN  
&  
ASSESSMENT OF ENVIRONMENTAL EFFECTS  
RUAKAKA SERVICE CENTRE  
RUAKAKA***

Reference: FES 1359.002 February 2021 R1

Project Name DSI, RAP & AEE R1  
Ruakaka Service Centre, Ruakaka  
Project Number 1359.001  
File Reference M:\2020 Jobs\Ruakaka Service Centre\DSI\01 Report\1359.002\_DSI\_PS\_DRAFT.docx  
Date February 2021

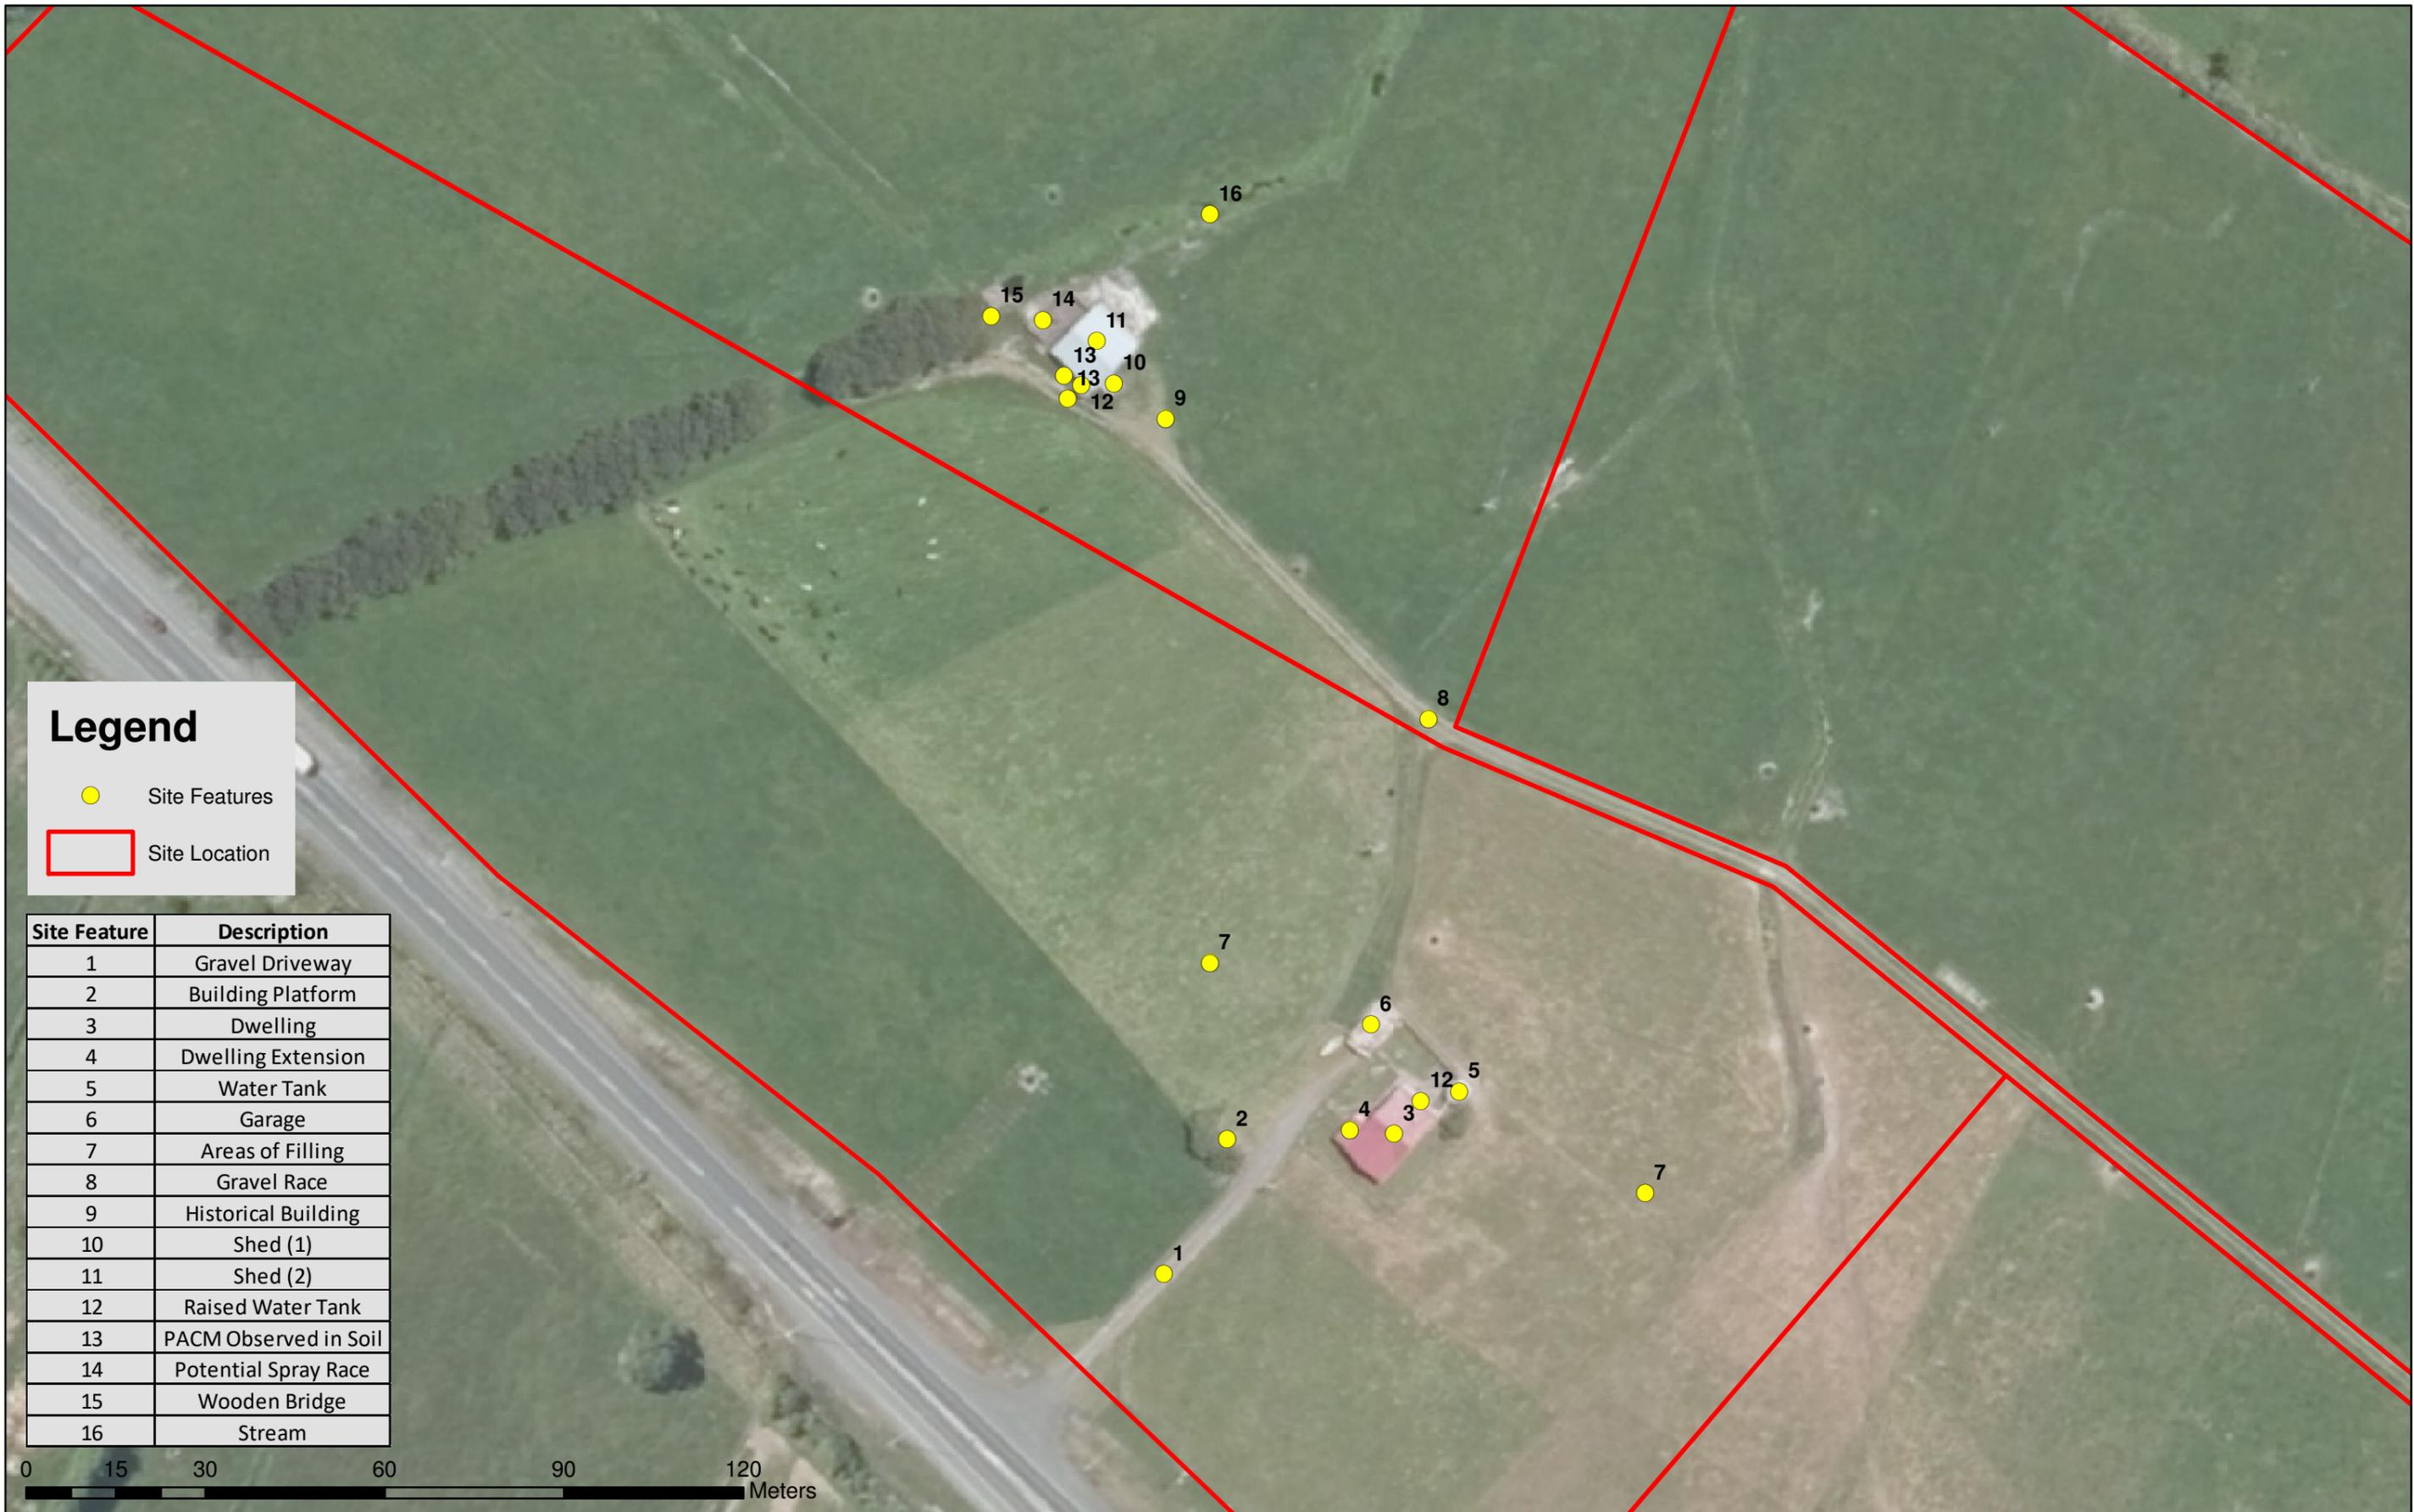
Drawing Number: 1359.002.02
Drawn By: PS
Checked By: DO'R
Date: 03/06/2020

Site Feature	Description
1	Gravel Driveway
2	Building Platform
3	Dwelling
4	Dwelling Extension
5	Water Tank
6	Garage
7	Areas of Filling
8	Gravel Race
9	Historical Building
10	Shed (1)
11	Shed (2)
12	Raised Water Tank
13	PACM Observed in Soil
14	Potential Spray Race
15	Wooden Bridge
16	Stream

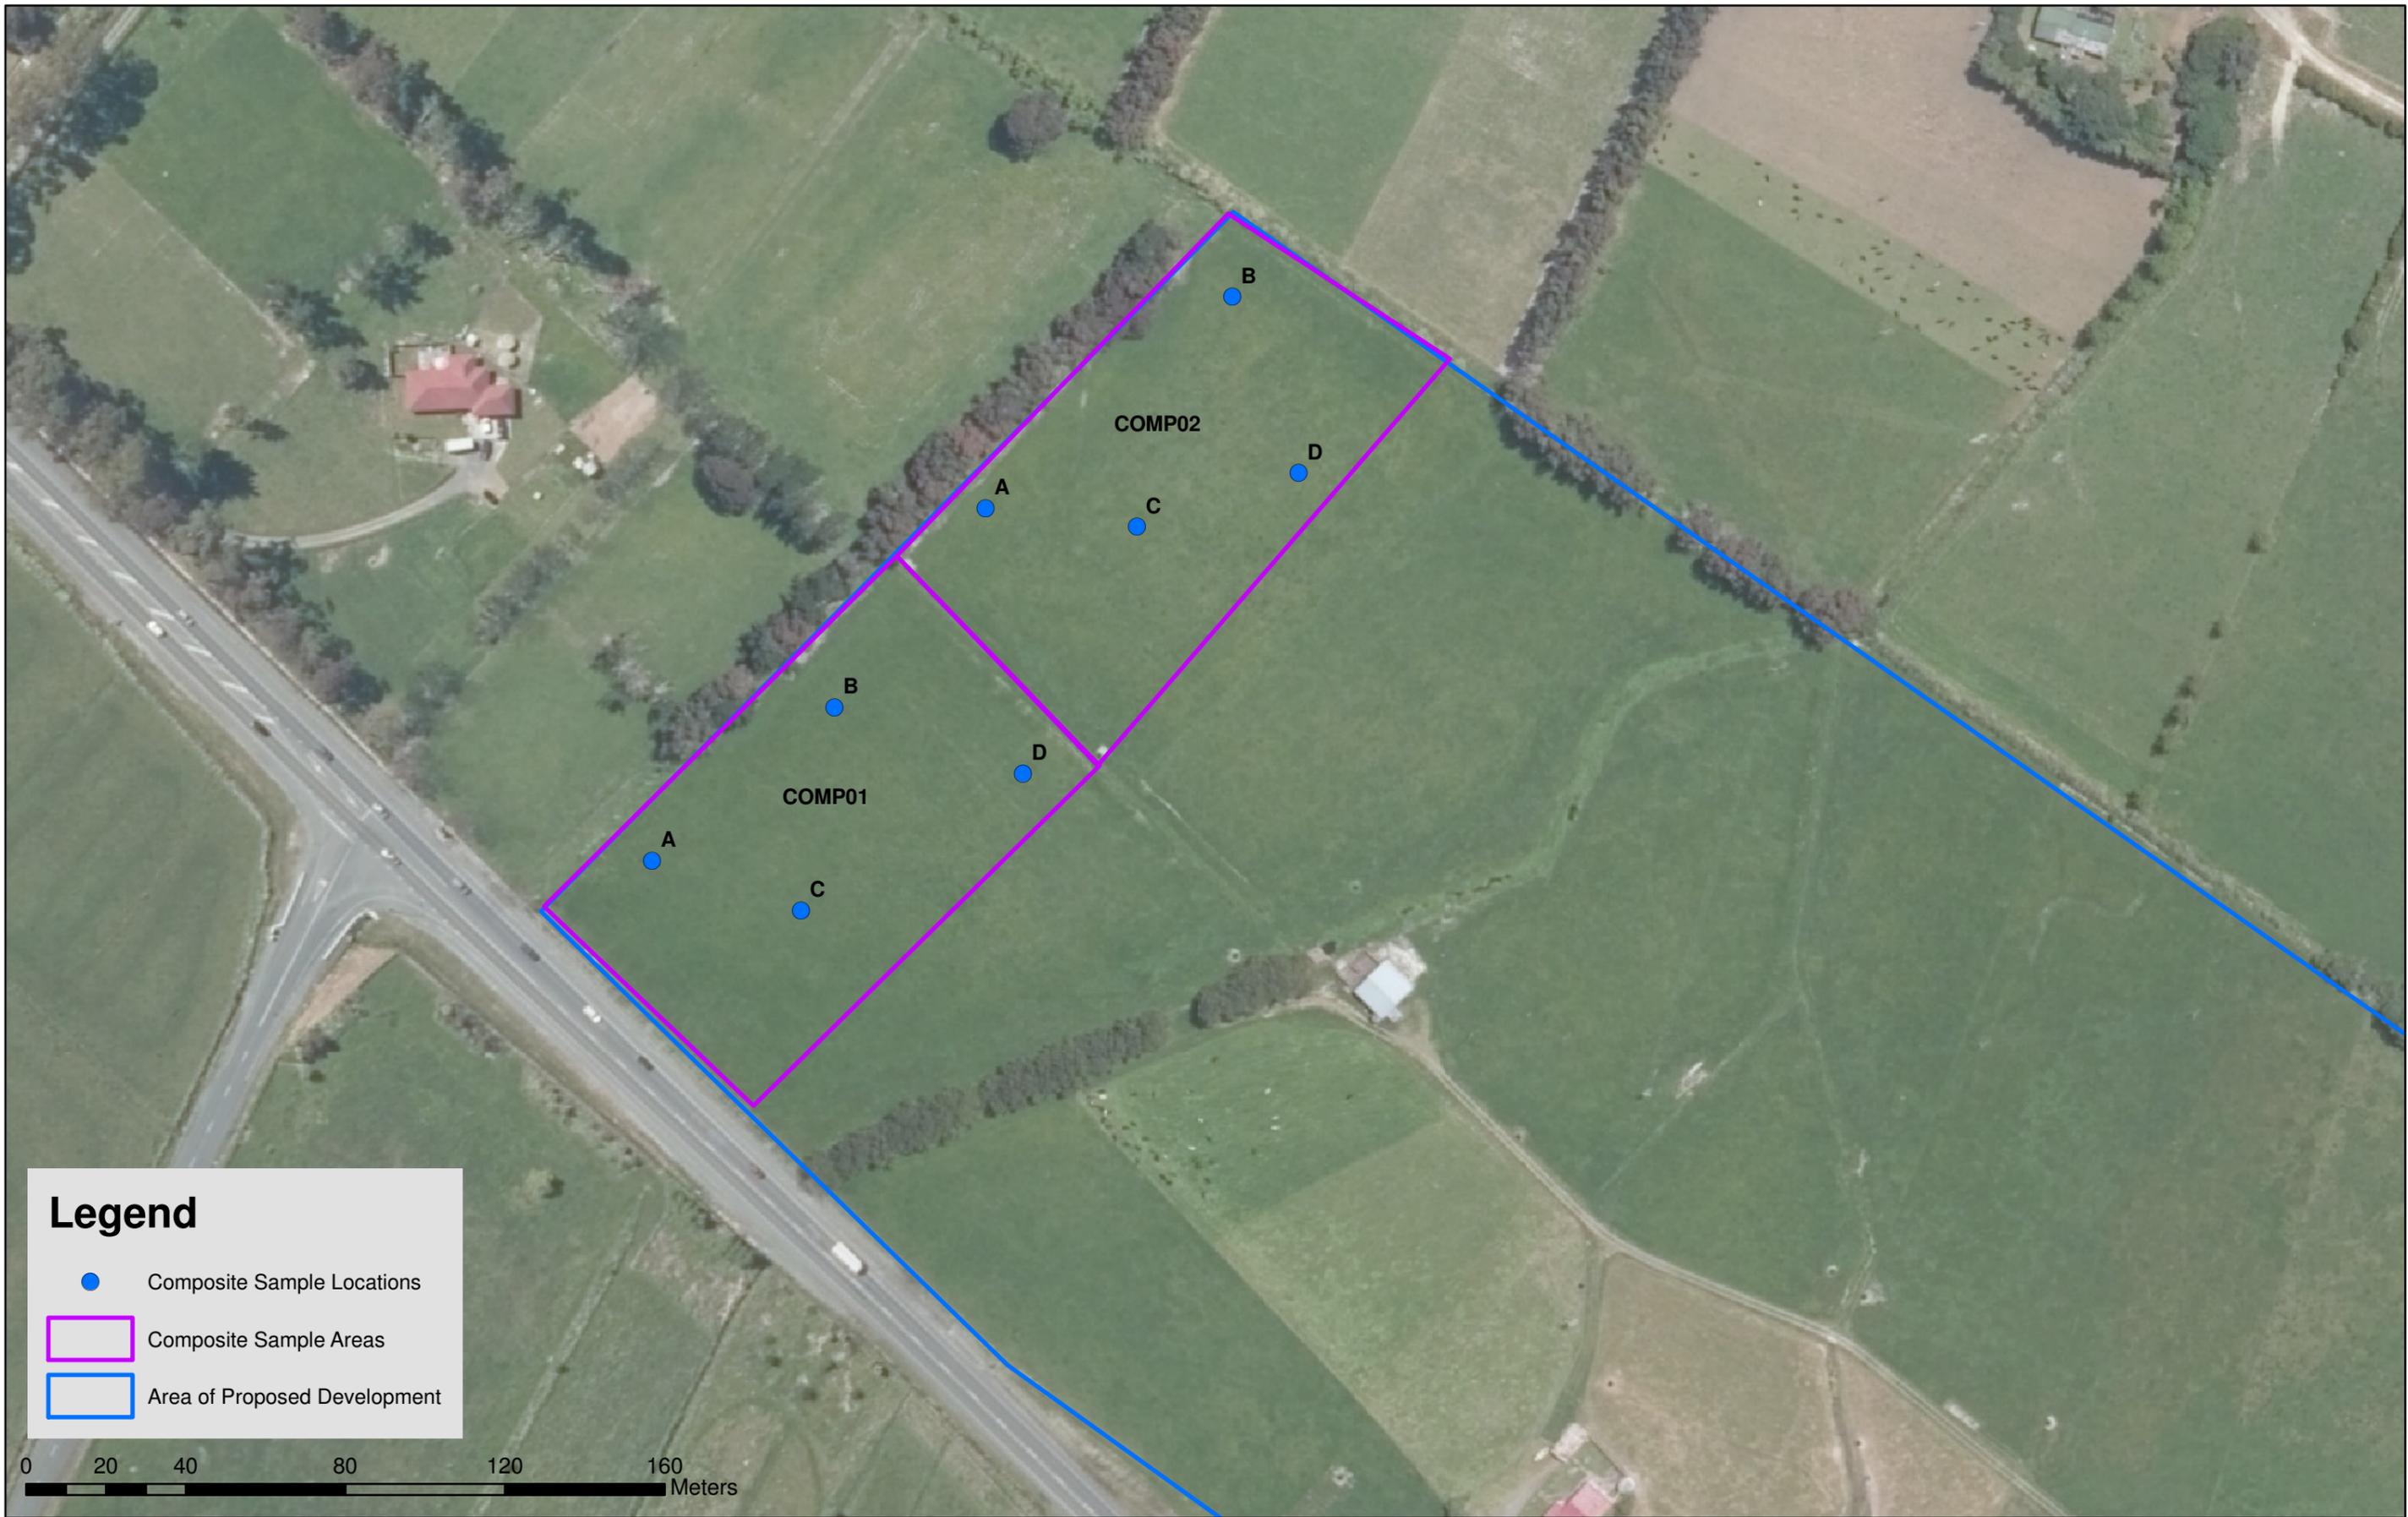
Drawing Number: 1359.002.03-1
Drawn By: PS
Checked By: DO'R
Date: 03/06/2020

- Composite Sample Locations
- Composite Sample Areas
- Area of Proposed Development

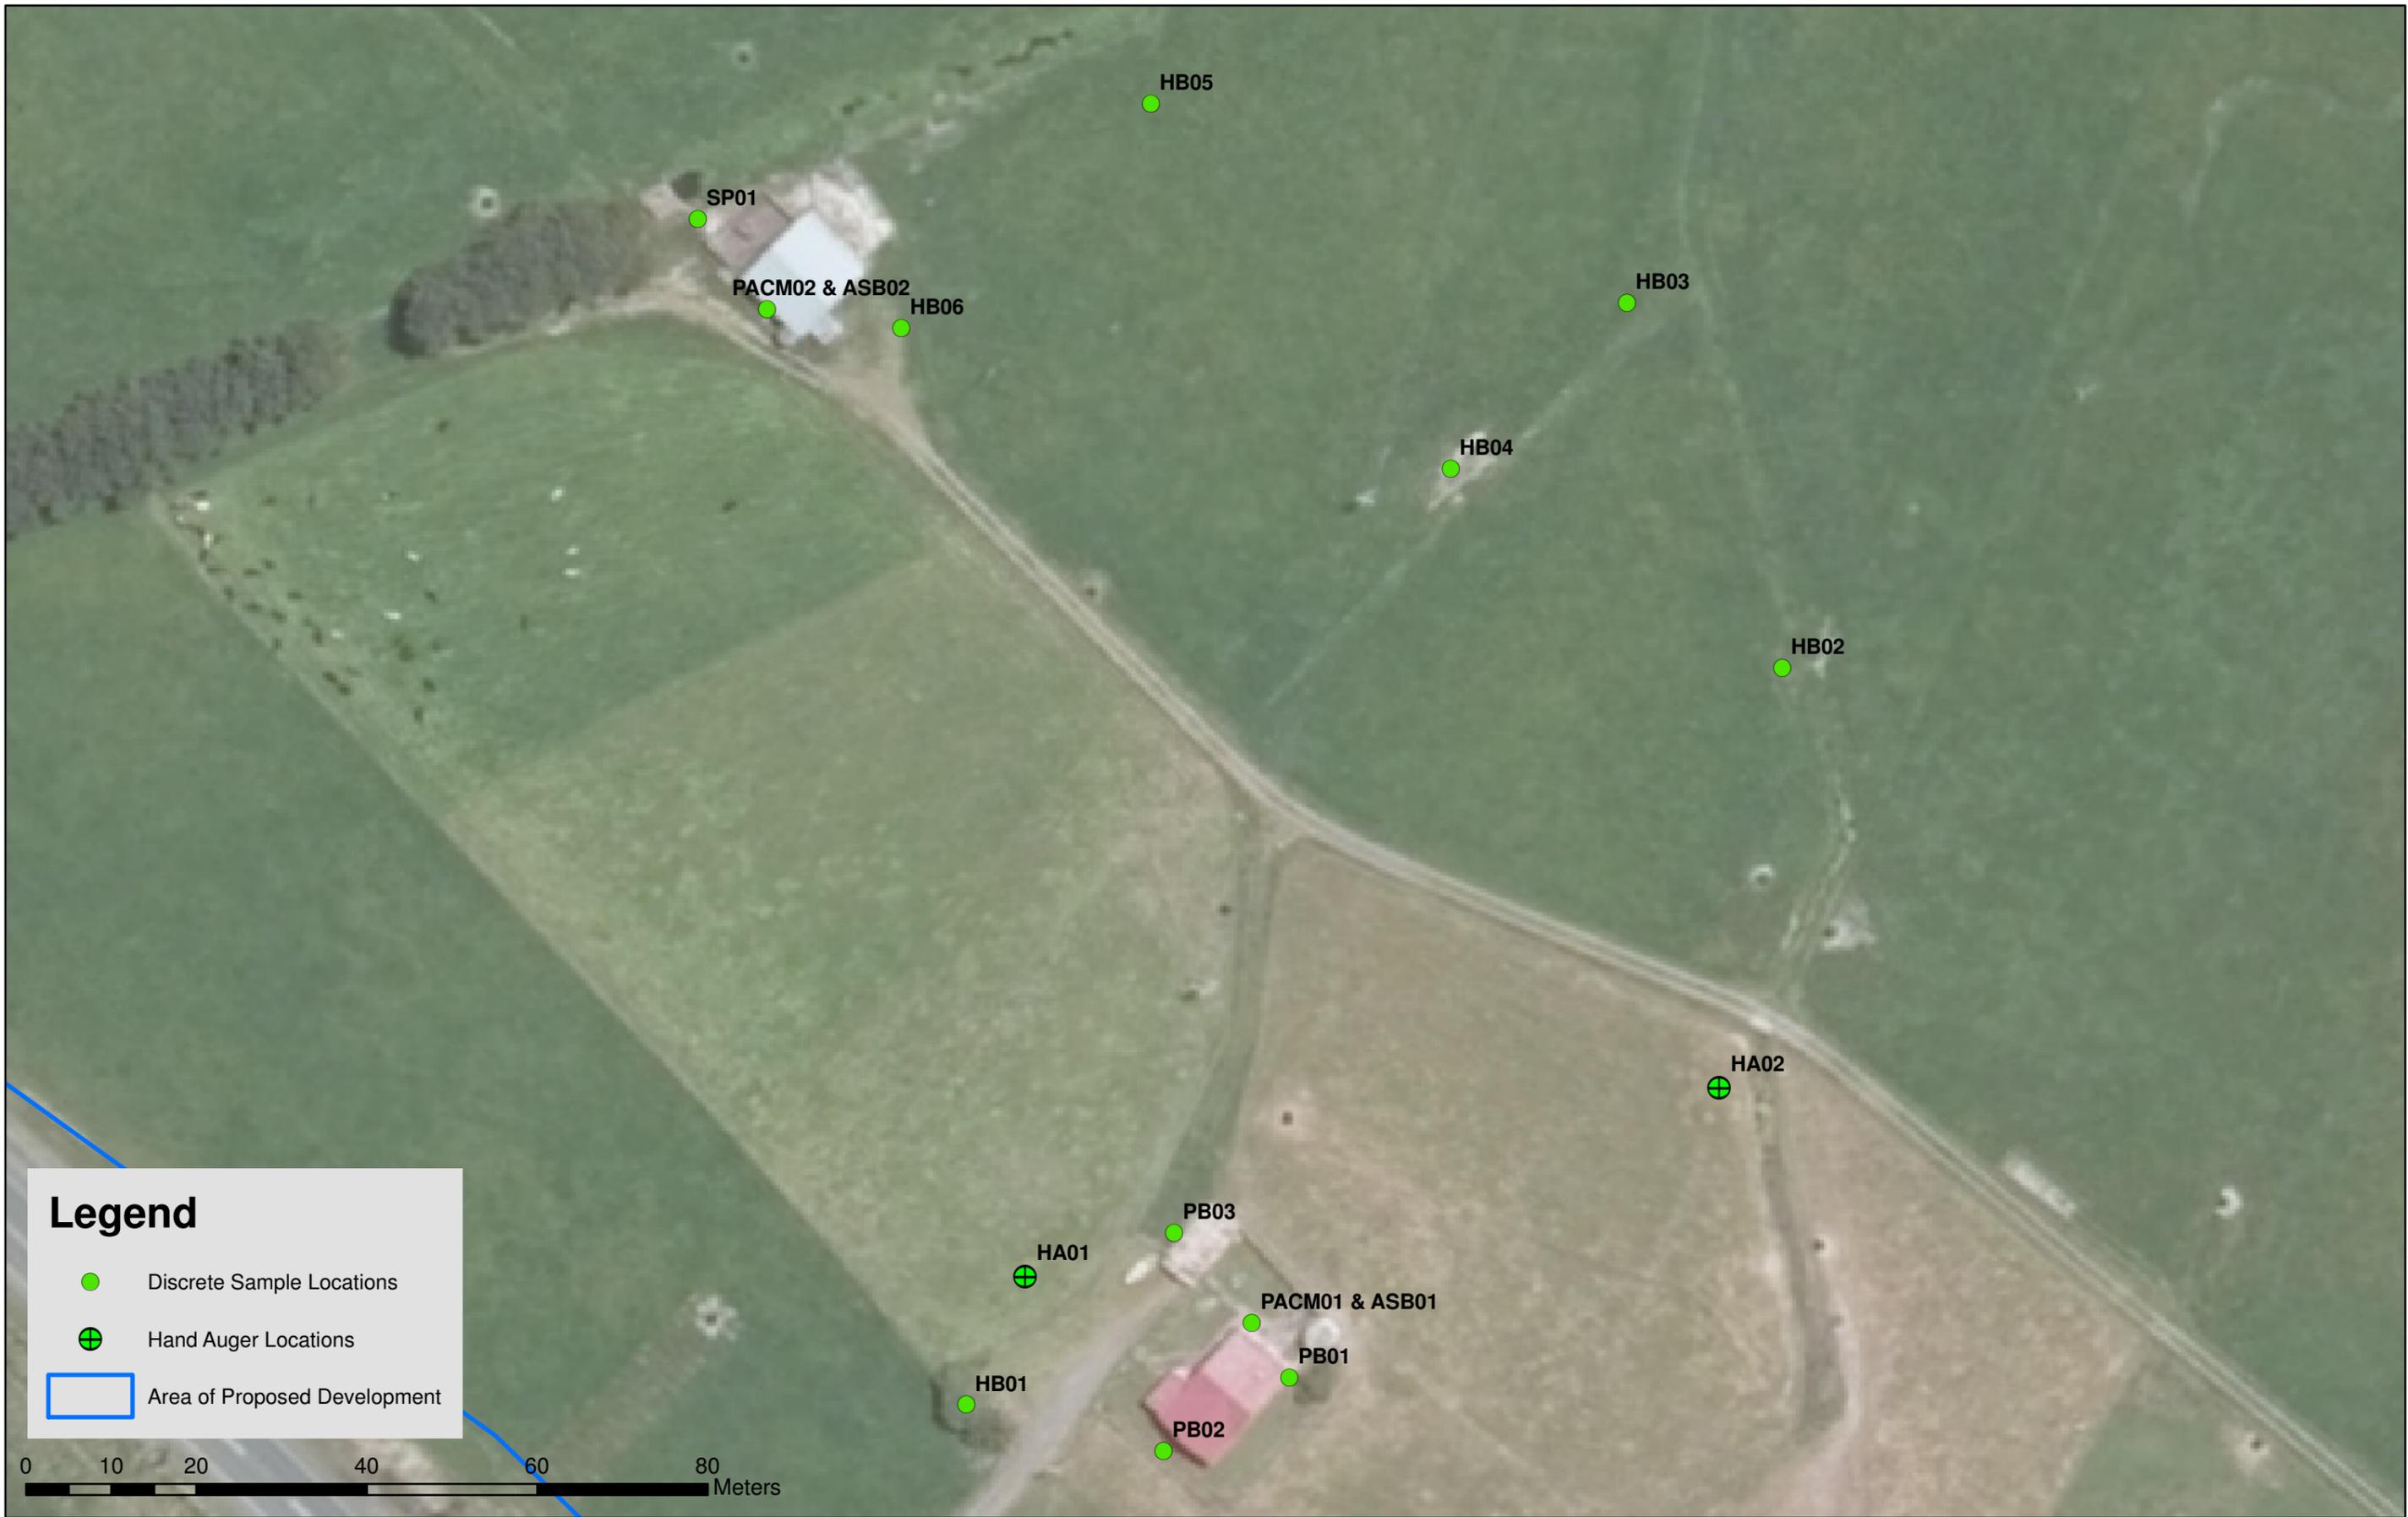
Drawing Number: 1359.002.03-2
Drawn By: PS
Checked By: DO'R
Date: 03/06/2020

- Discrete Sample Locations
- ⊕ Hand Auger Locations
- Area of Proposed Development

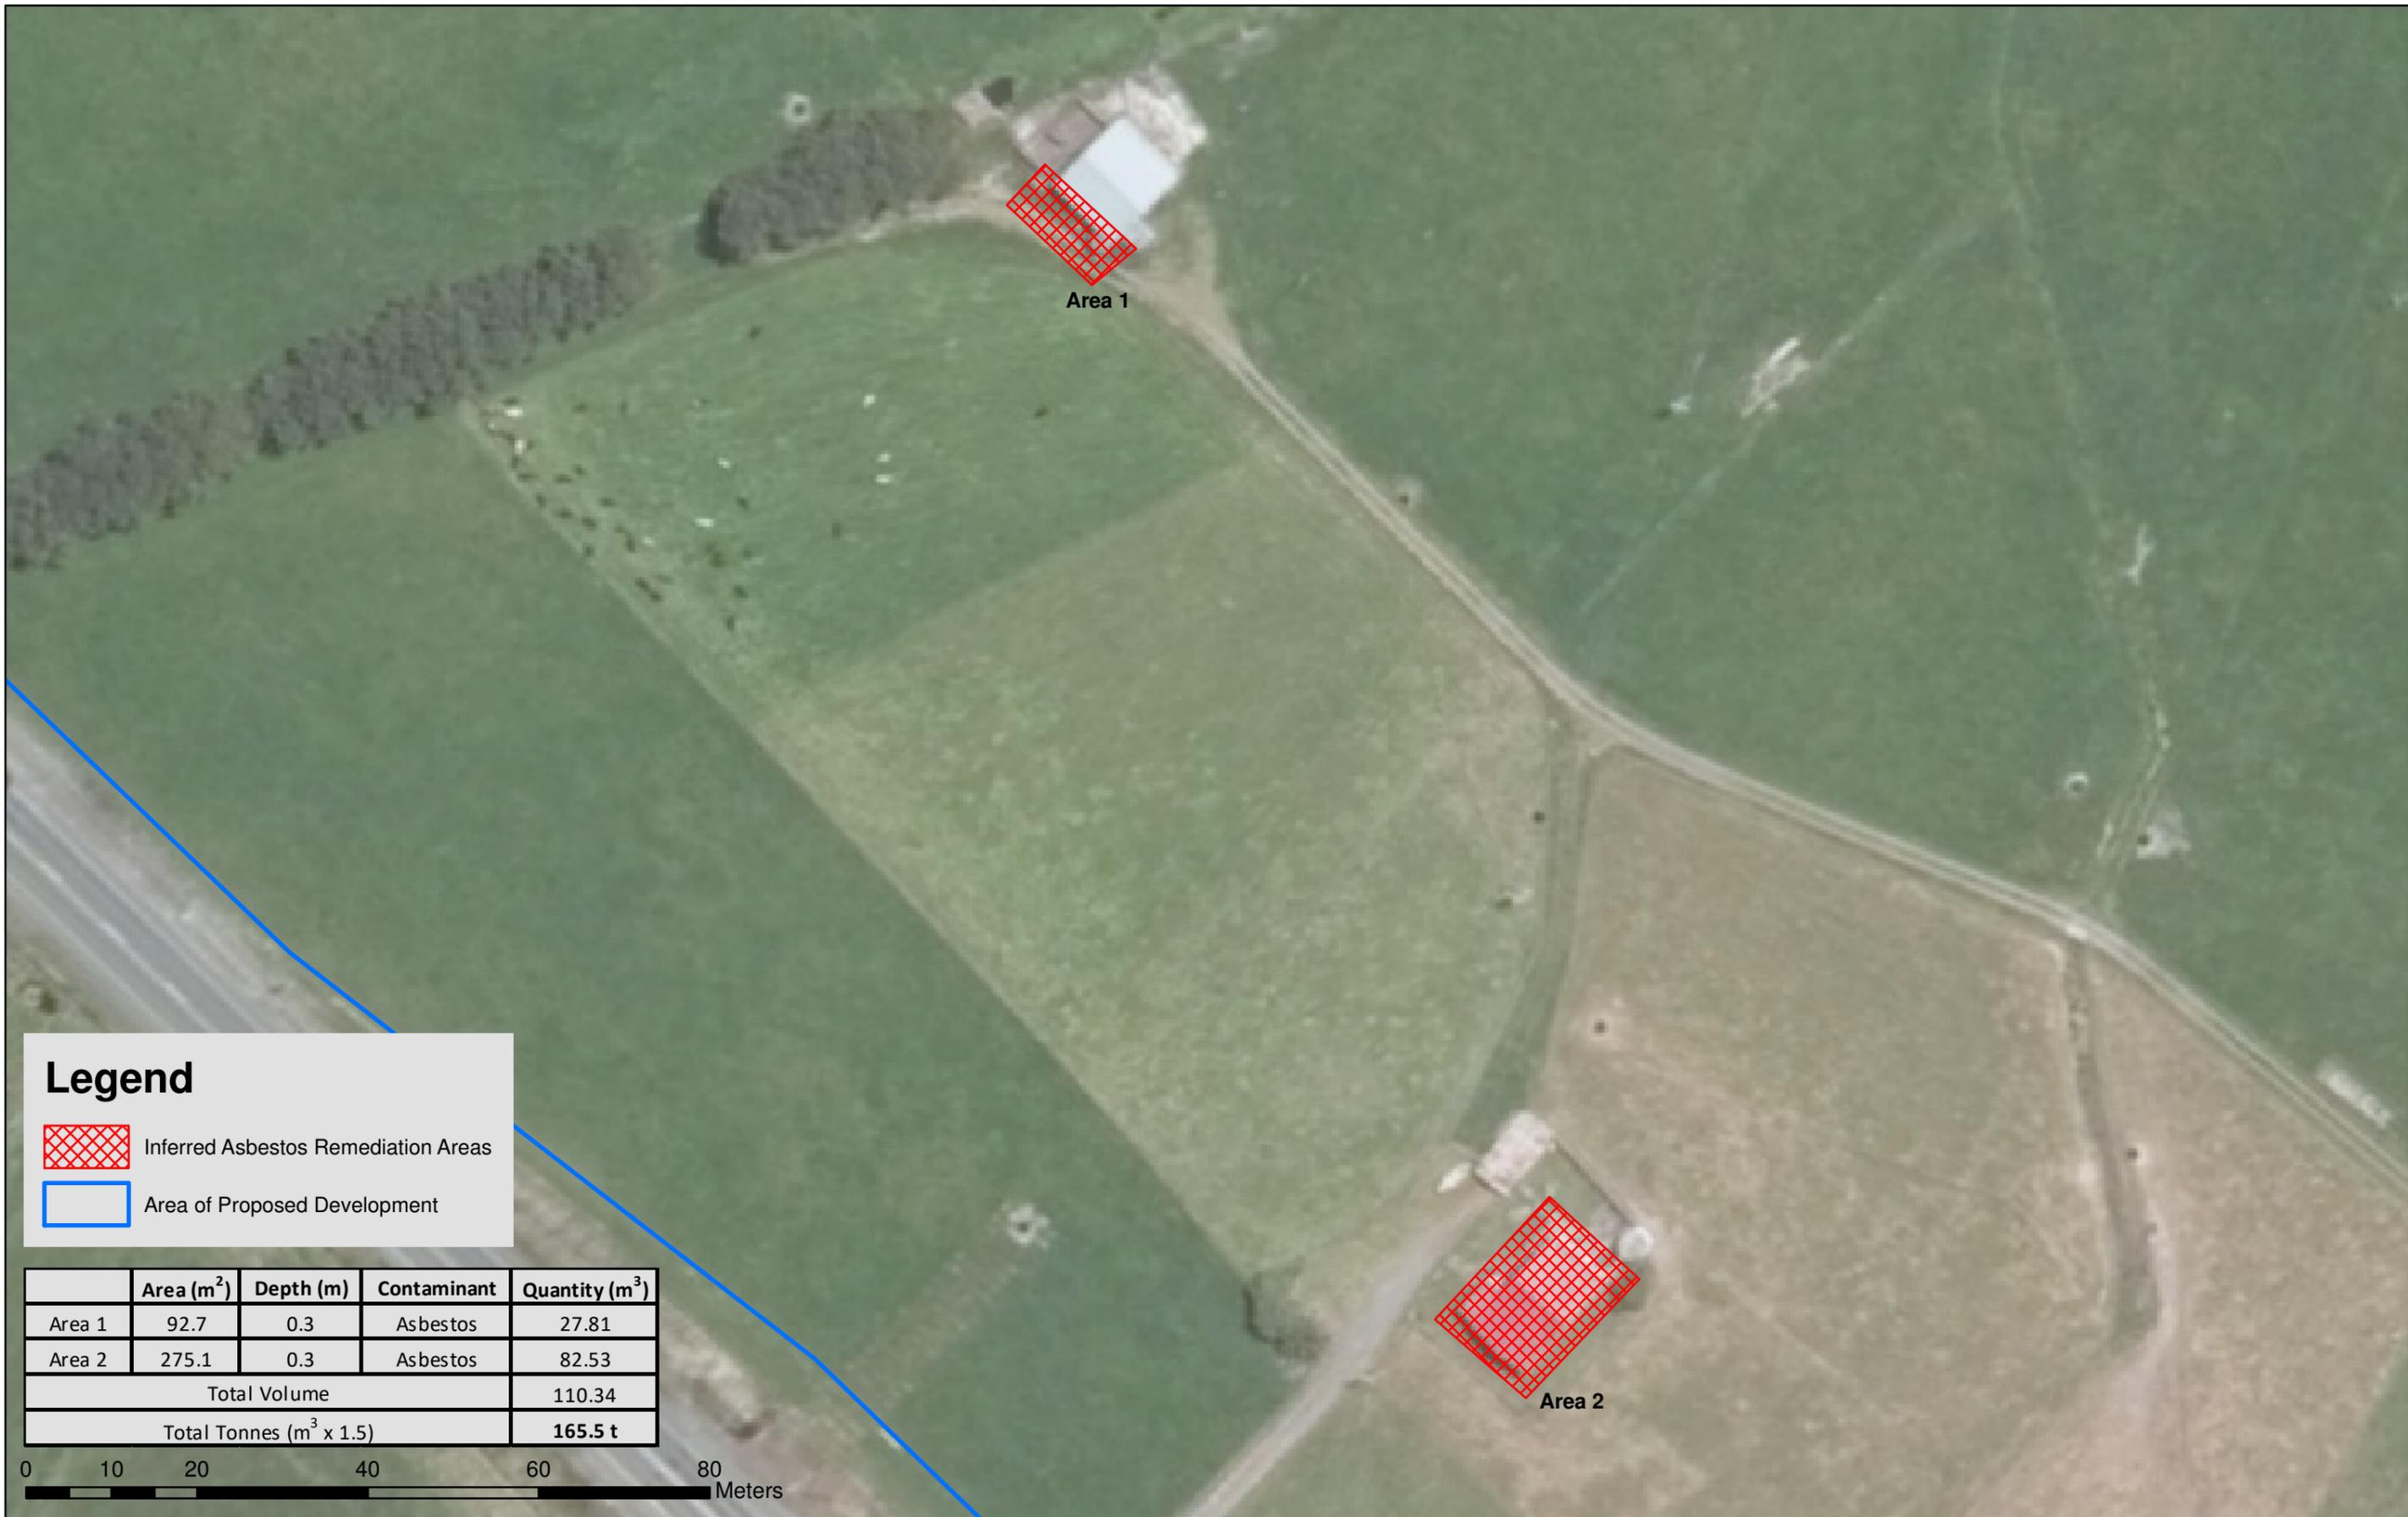
Drawing Number: 1359.002.04-1  
 Drawn By: PS  
 Checked By: DO'R  
 Date: 11/06/2020

The surface samples ASB01 & ASB02 taken from the areas of observed PACM in the soil profile was elevated above the adopted human health criteria for asbestos fibres. In addition to containing visual evidence of asbestos containing material within the soil profiles of these areas (Area 1 & Area 2).

- Inferred Asbestos Remediation Areas
- Area of Proposed Development

Area 2 is encompassed within Area 3 so the total volume recommended for remediation is 1305.3 m<sup>3</sup>. The inferred extent of the contaminated soil at the site is presented in Figures 4-1 and 4-2. The extent of Area 3 is based on the extent of fill taken from the provided geotechnical information. This estimate is based on the sampling and results available following the site investigation and it should be noted that the volume may increase or decrease following inspection, delineation sampling and validation sampling.

As stated above, the remediation of the asbestos contaminated soils in Area 1 & 2 is required to be undertaken under the supervision of a Class B licensed asbestos removalist. It is recommended that a licensed asbestos removalist is present for the duration of the removal works to ensure that the procedures outlined in this plan and the ARCP are adhered to in order to mitigate the potential effects on human health.

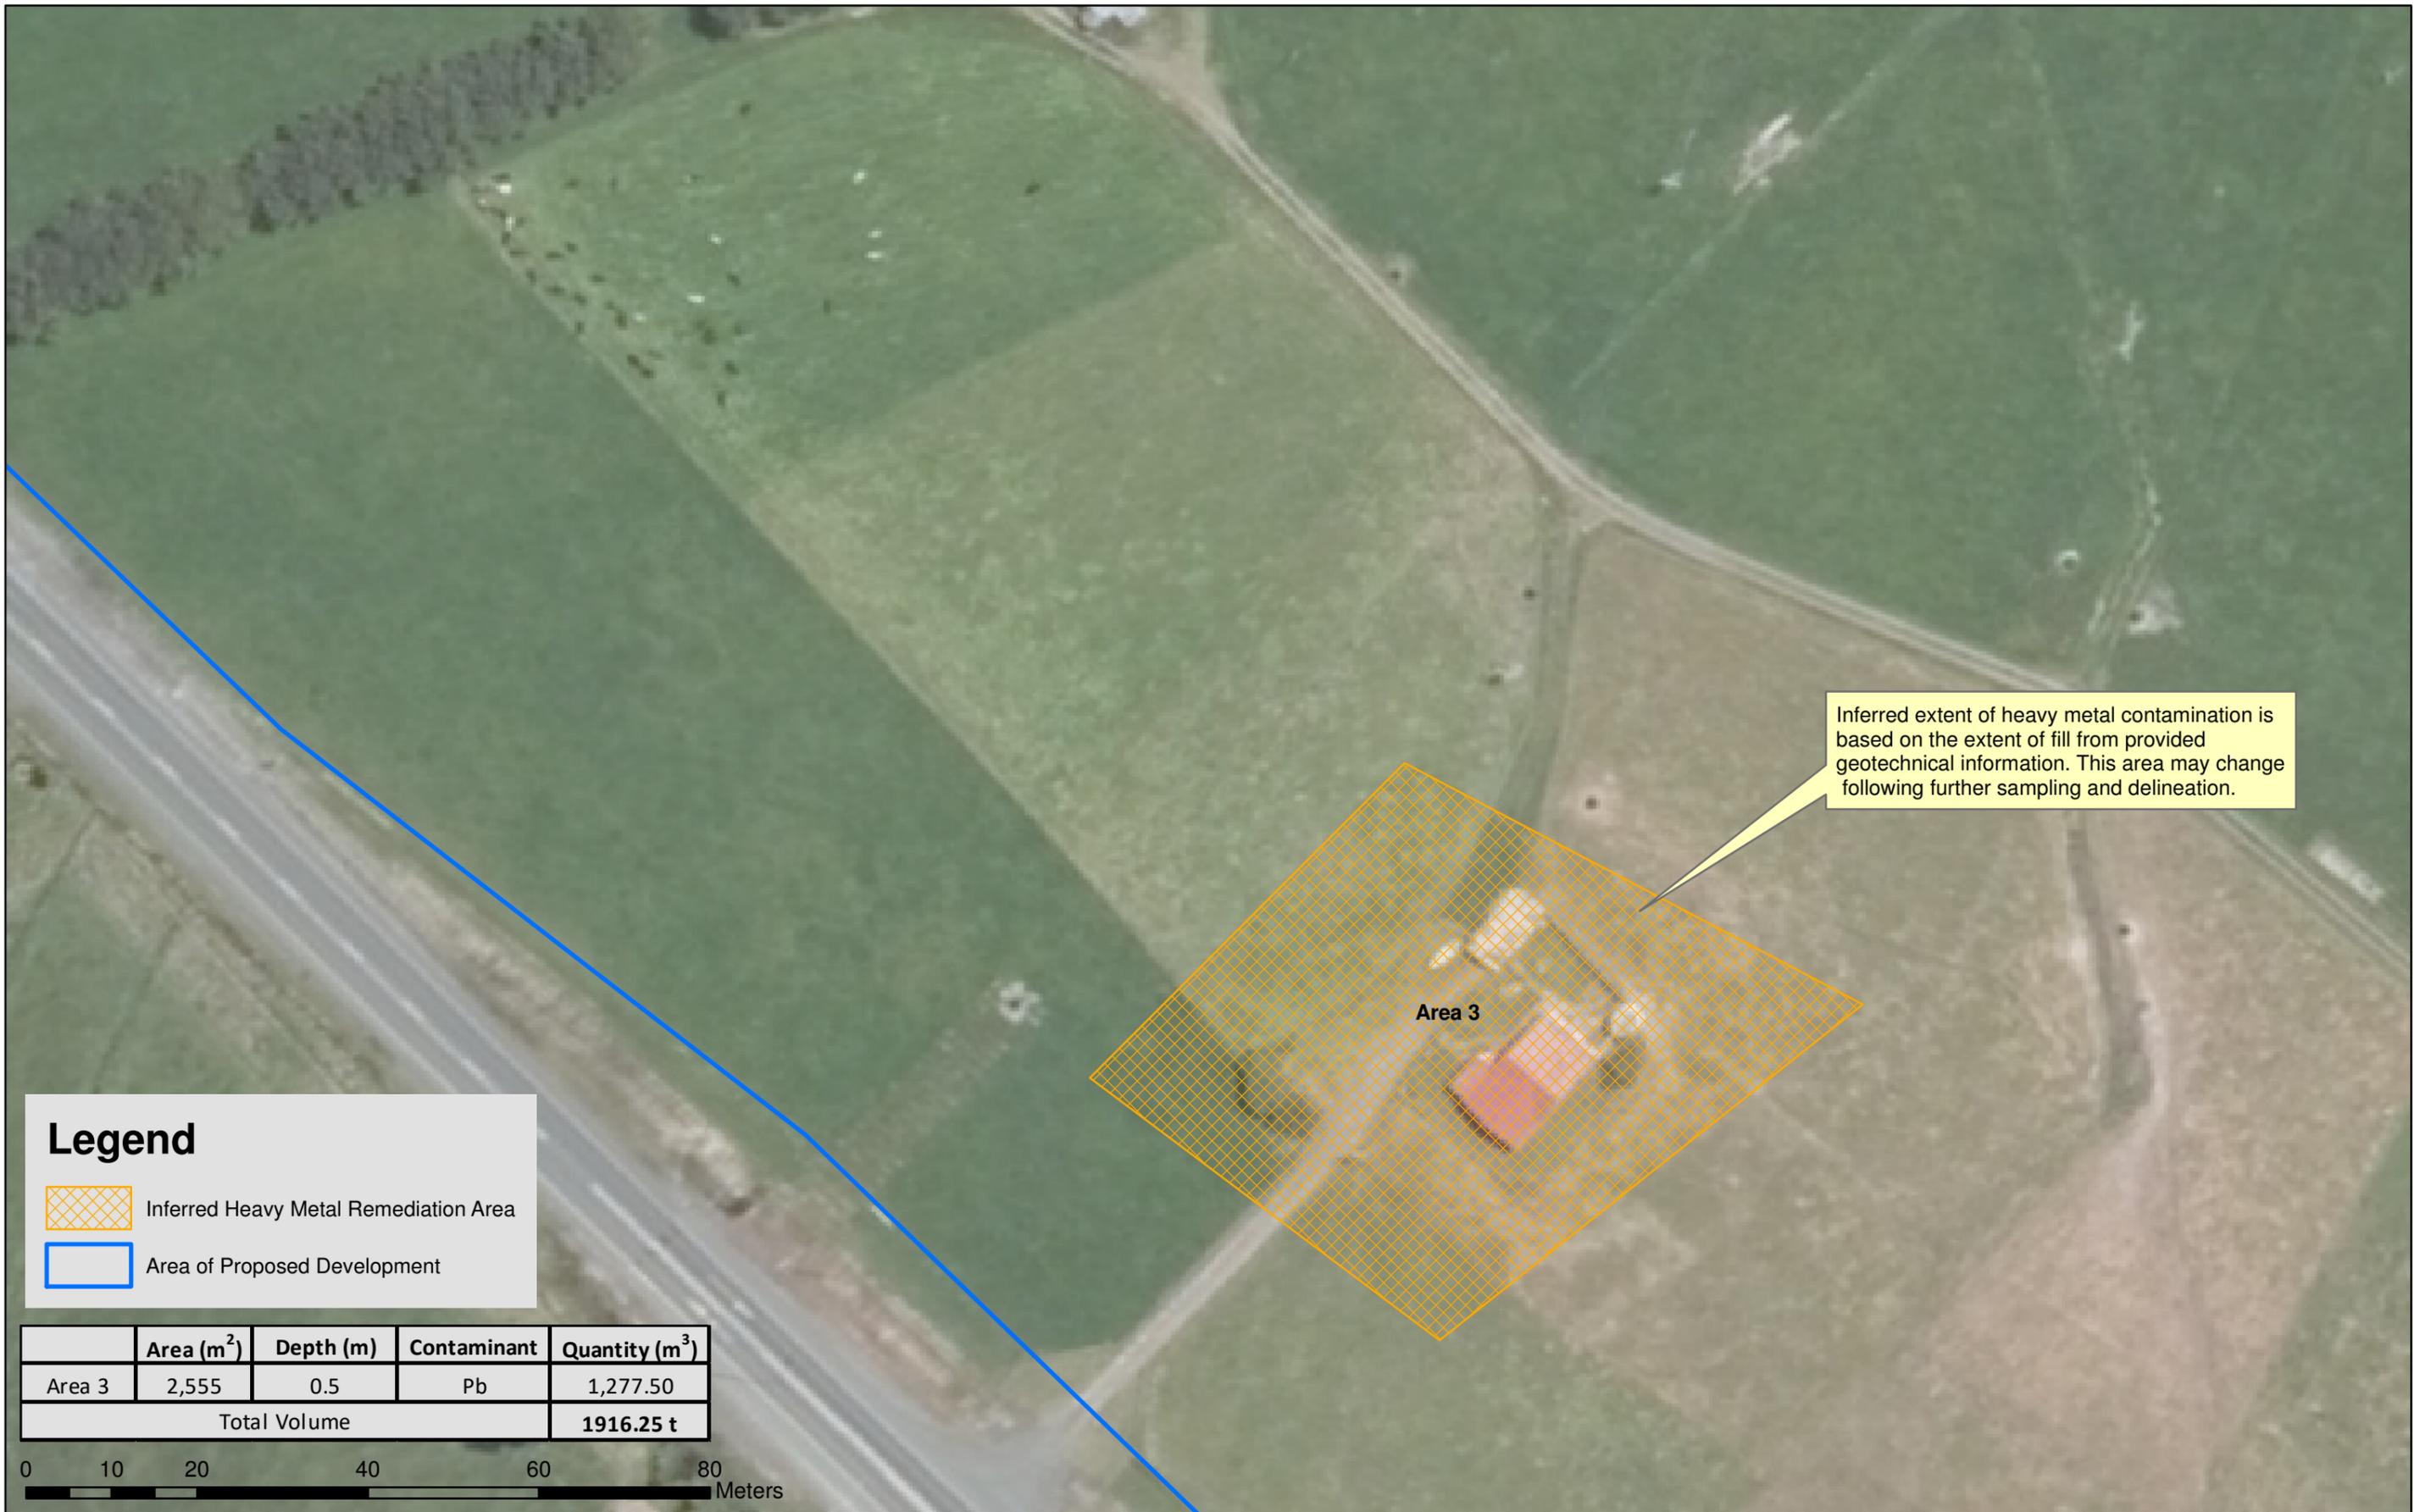
1359.002	Drawing Number: 1359.002.04-2
	Drawn By: PS
	Checked By: DO'R
	Date: 11/06/2020

Inferred extent of heavy metal contamination is based on the extent of fill from provided geotechnical information. This area may change following further sampling and delineation.

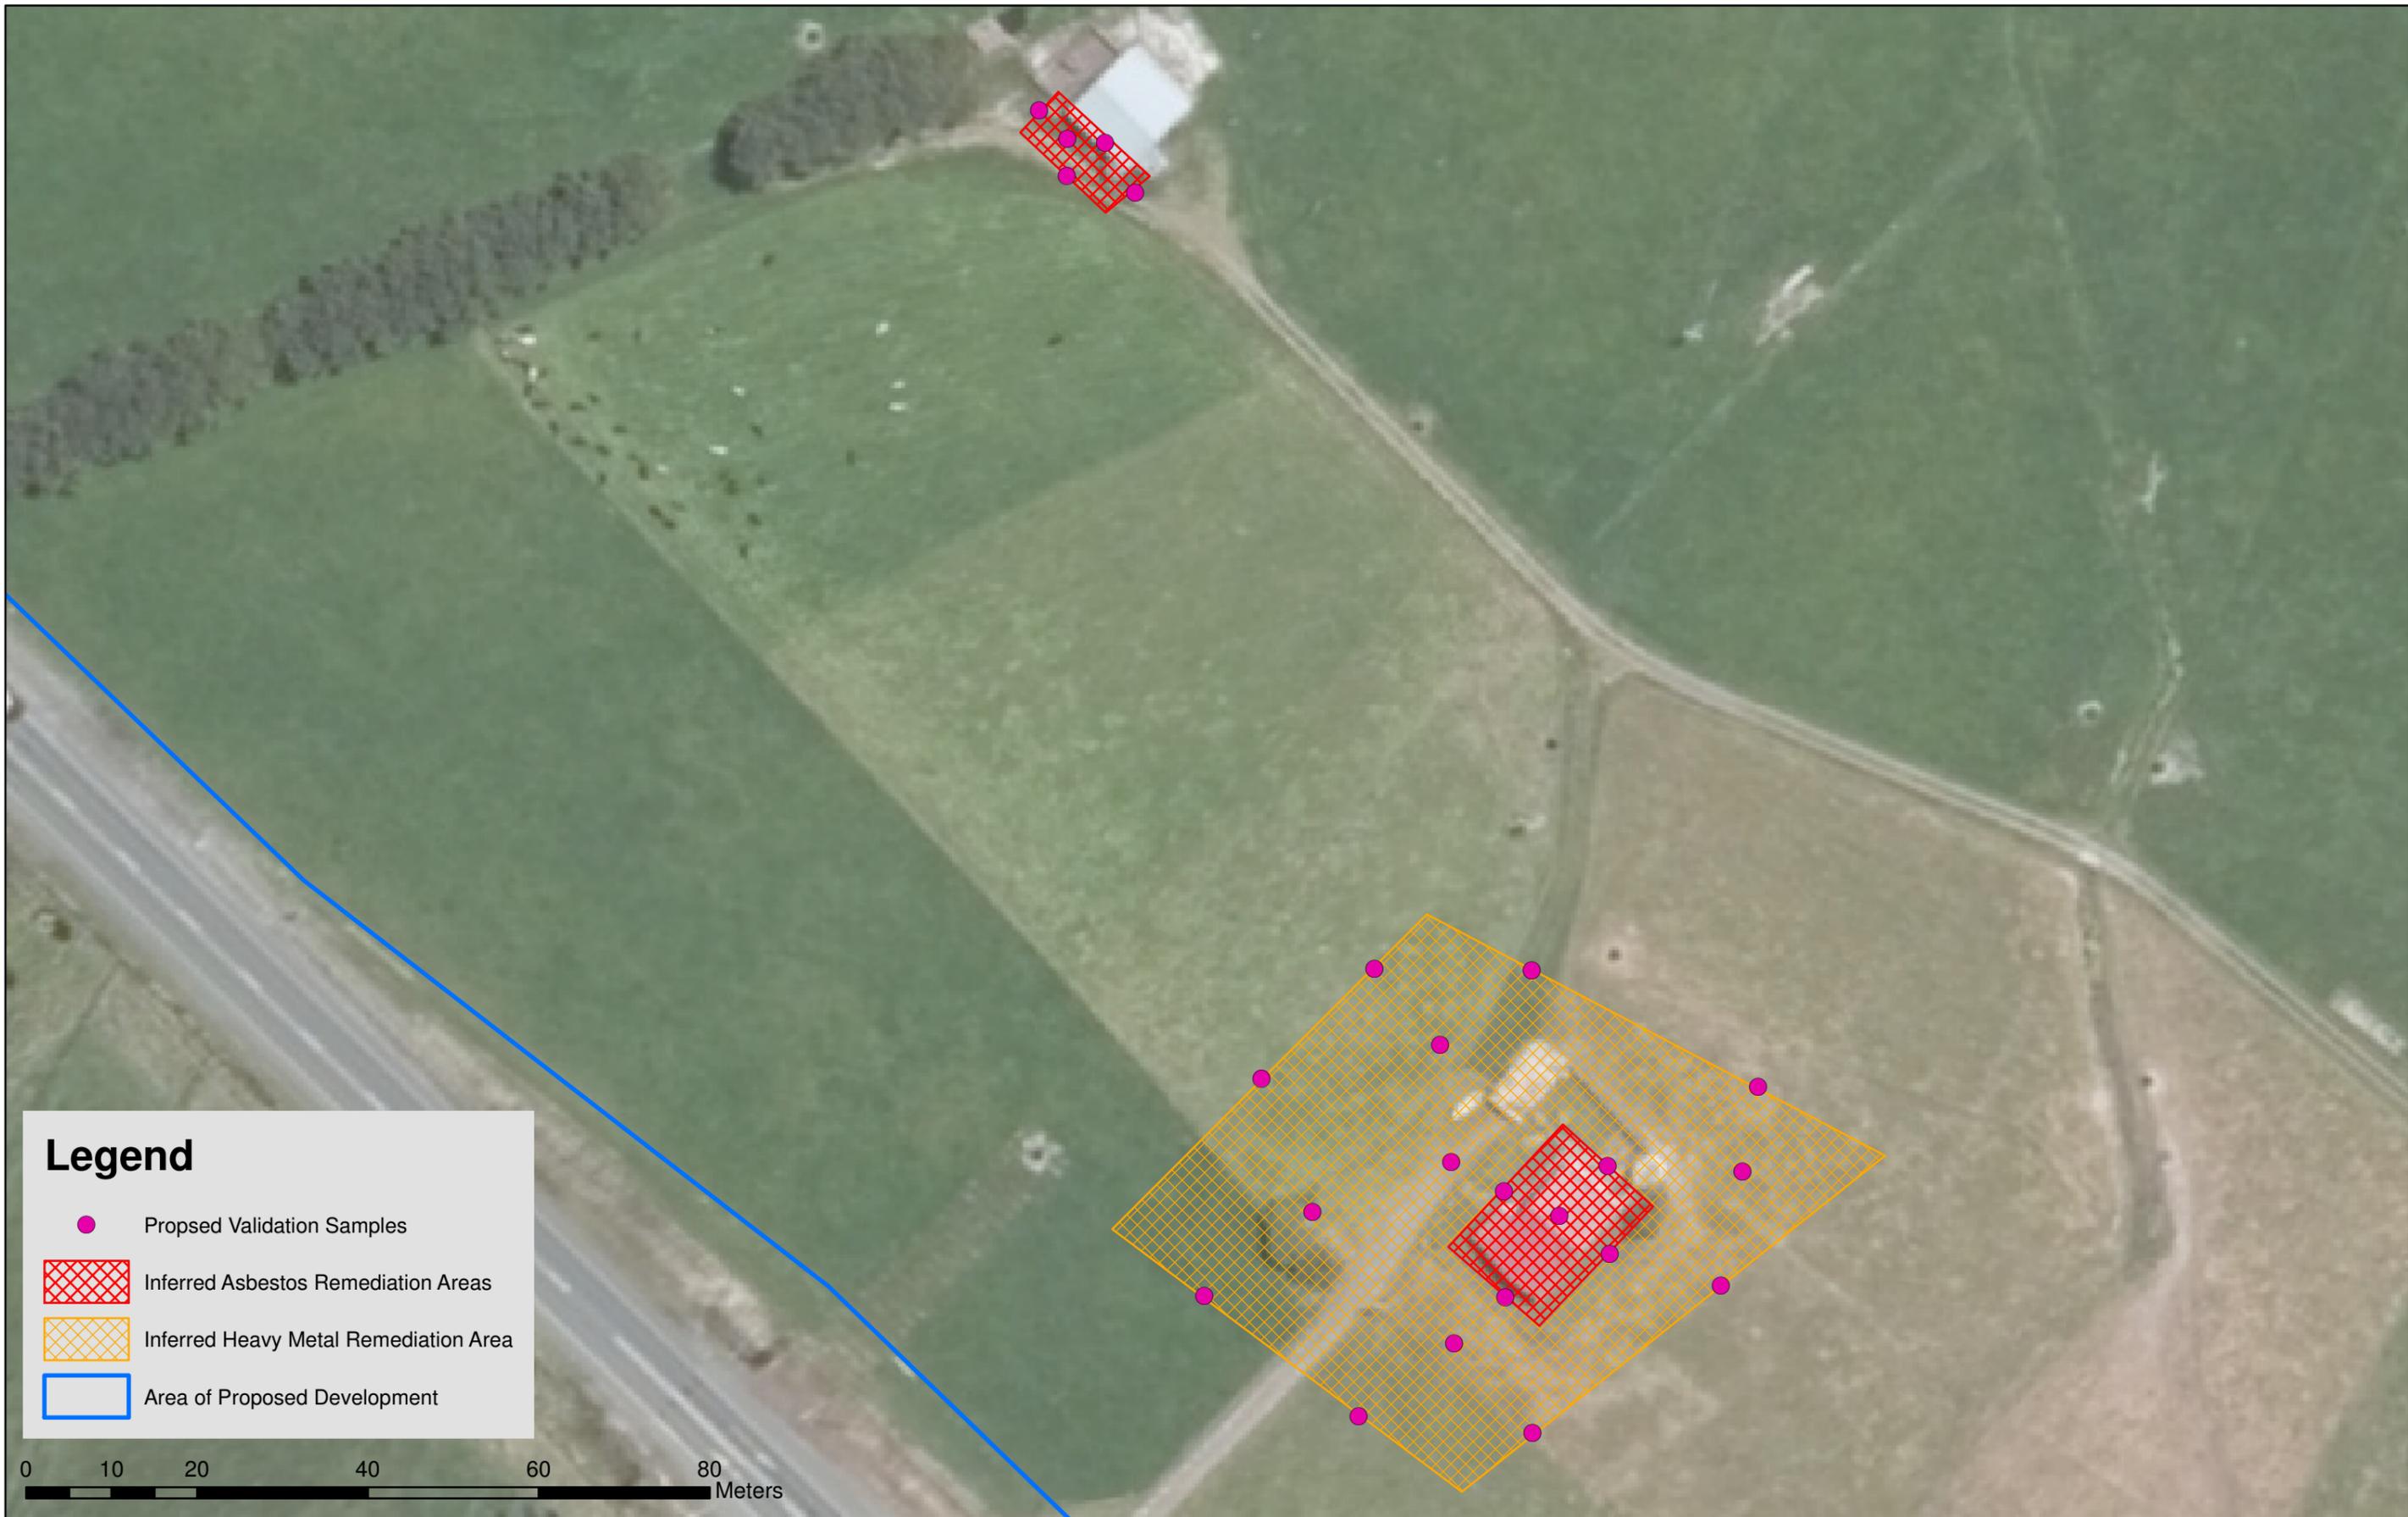
Drawing Number: 1359.002.05
	1359.002	Checked By: DO'R	Date: 11/06/2020

- Proposed Validation Samples
- Inferred Asbestos Remediation Areas
- Inferred Heavy Metal Remediation Area
- Area of Proposed Development

Following the proposed works, it is recommended that a site validation report is prepared. The site validation report should contain sufficient detail to address the following matters:
