***DETAILED SITE INVESTIGATION  
REMEDIACTION ACTION PLAN  
&  
ASSESSMENT OF ENVIRONMENTAL EFFECTS  
RUAKAKA SERVICE CENTRE  
RUAKAKA***

Reference: FES 1359.002 February 2021 R1

Project Name DSI, RAP & AEE R1  
Ruakaka Service Centre, Ruakaka  
Project Number 1359.001  
File Reference M:\2020 Jobs\Ruakaka Service Centre\DSI\01 Report\1359.002\_DSI\_PS\_DRAFT.docx  
Date February 2021

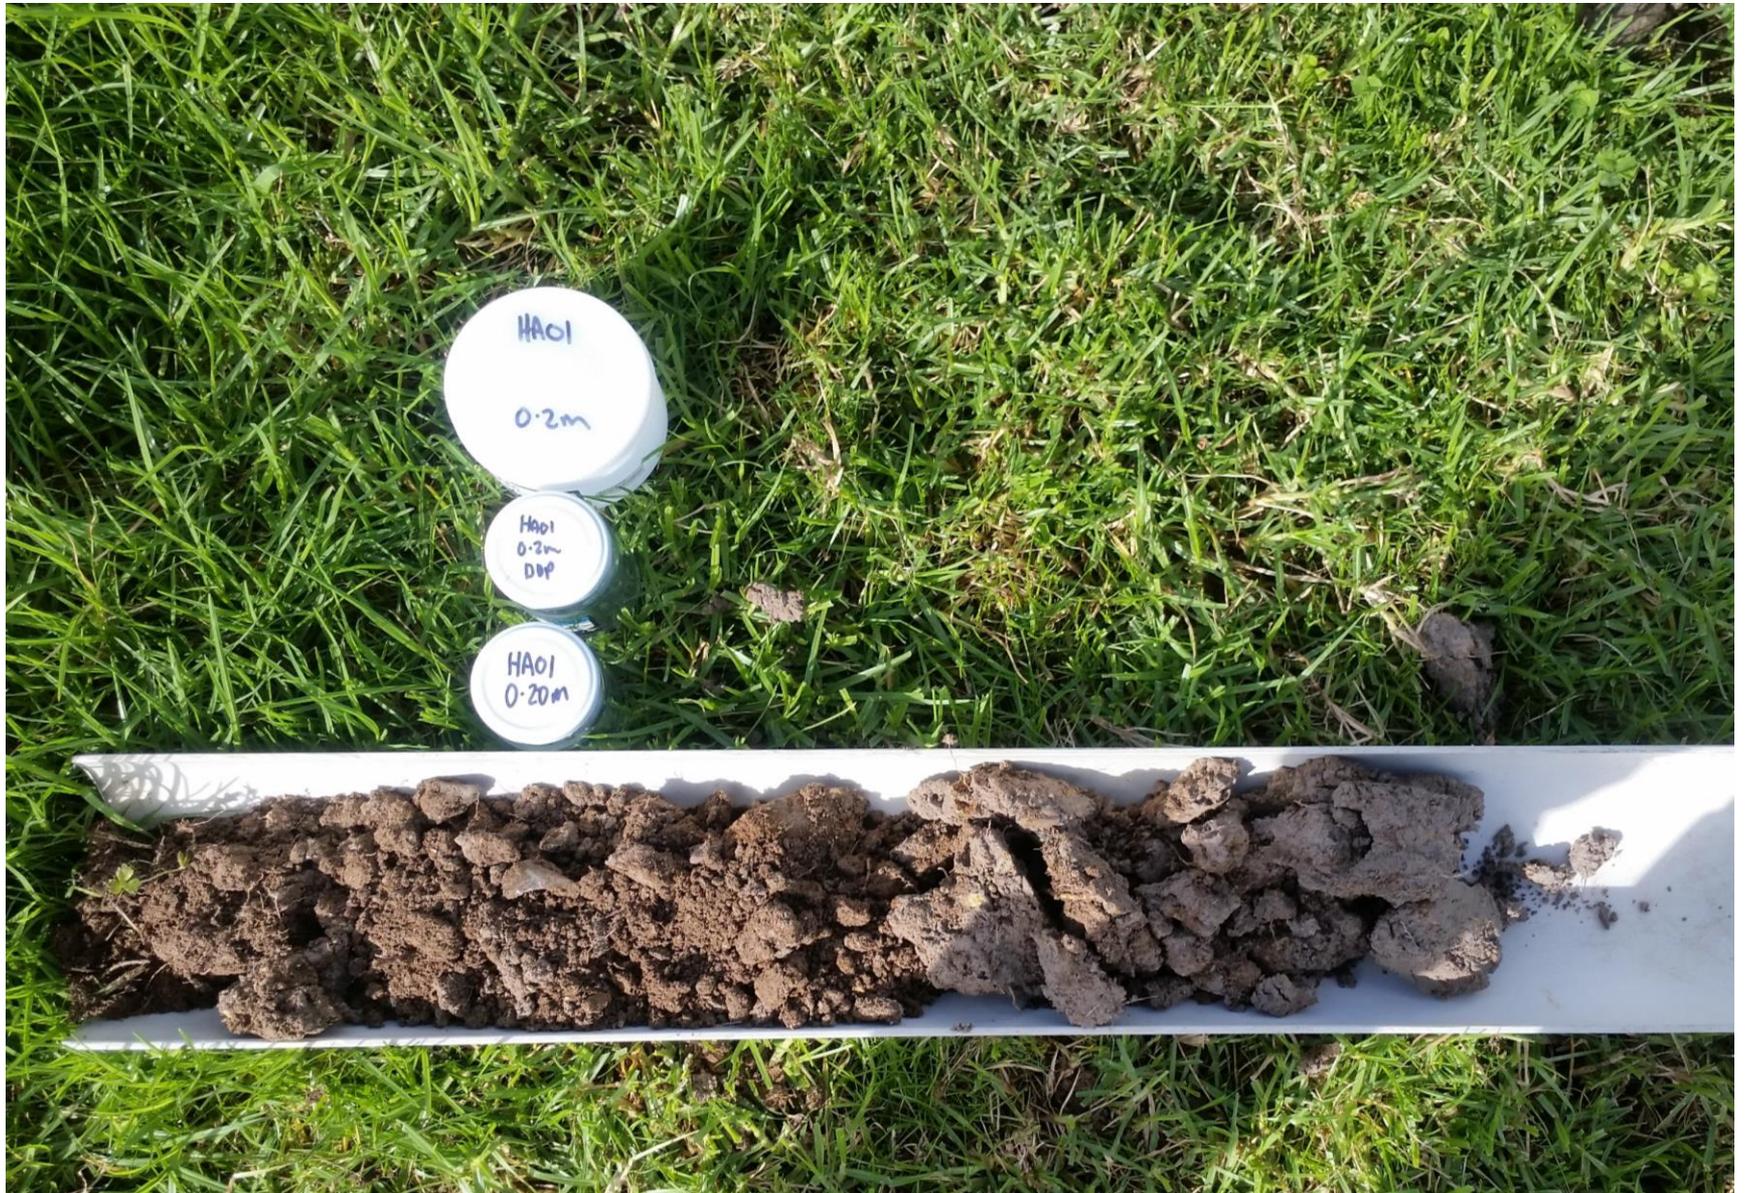
Topsoil	
				FILL clayey silt with trace sand and organics. Light grey with intermixed orange and brown streaks	
			HA01 0.2m		
0.5				Light grey silty CLAY - Natural Ground	
				Termination Depth at:0.6 m

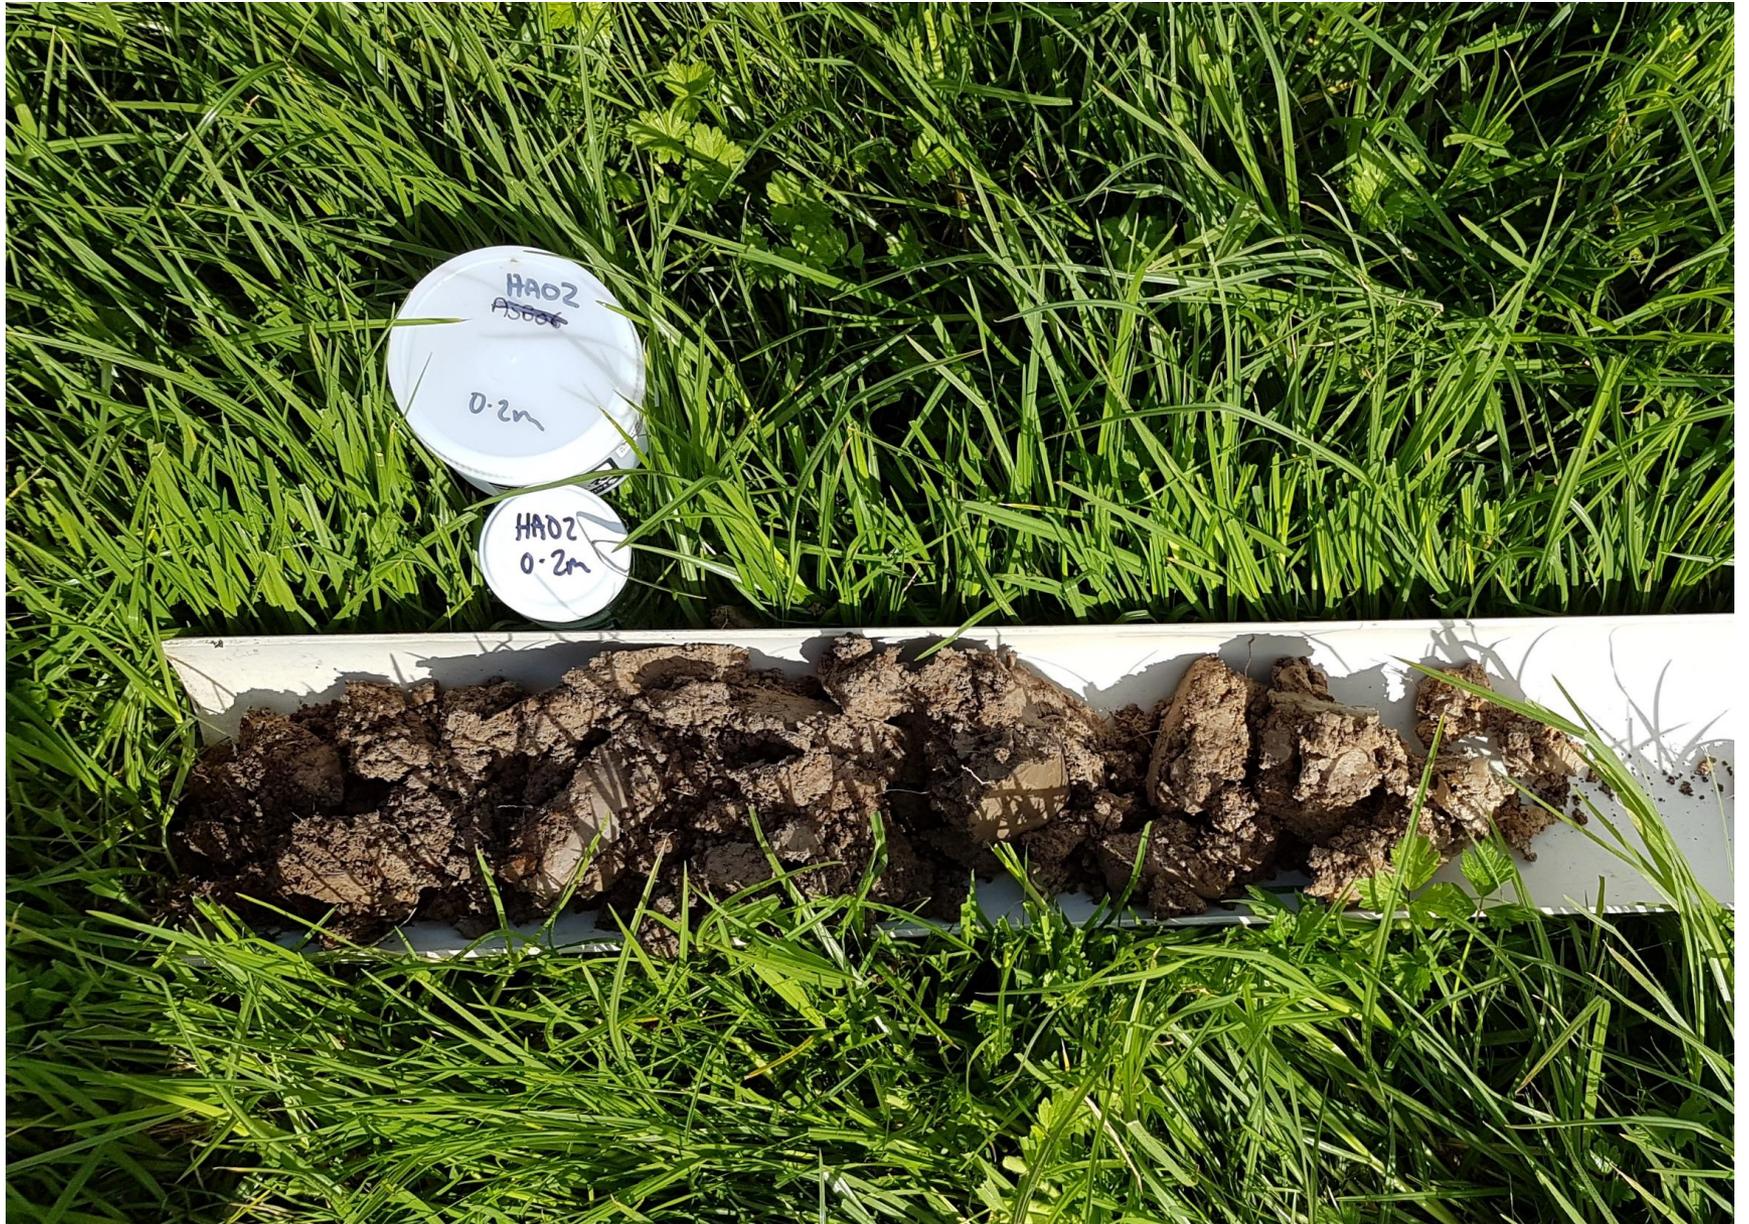
HA02

Light grey clayey SILT - Natural Ground	
				Termination Depth at:0.6 m
