Archaeological Assessment

The James Subdivision

115, 131 and 189 Three Mile Bush Road, Kamo

8 April 2021

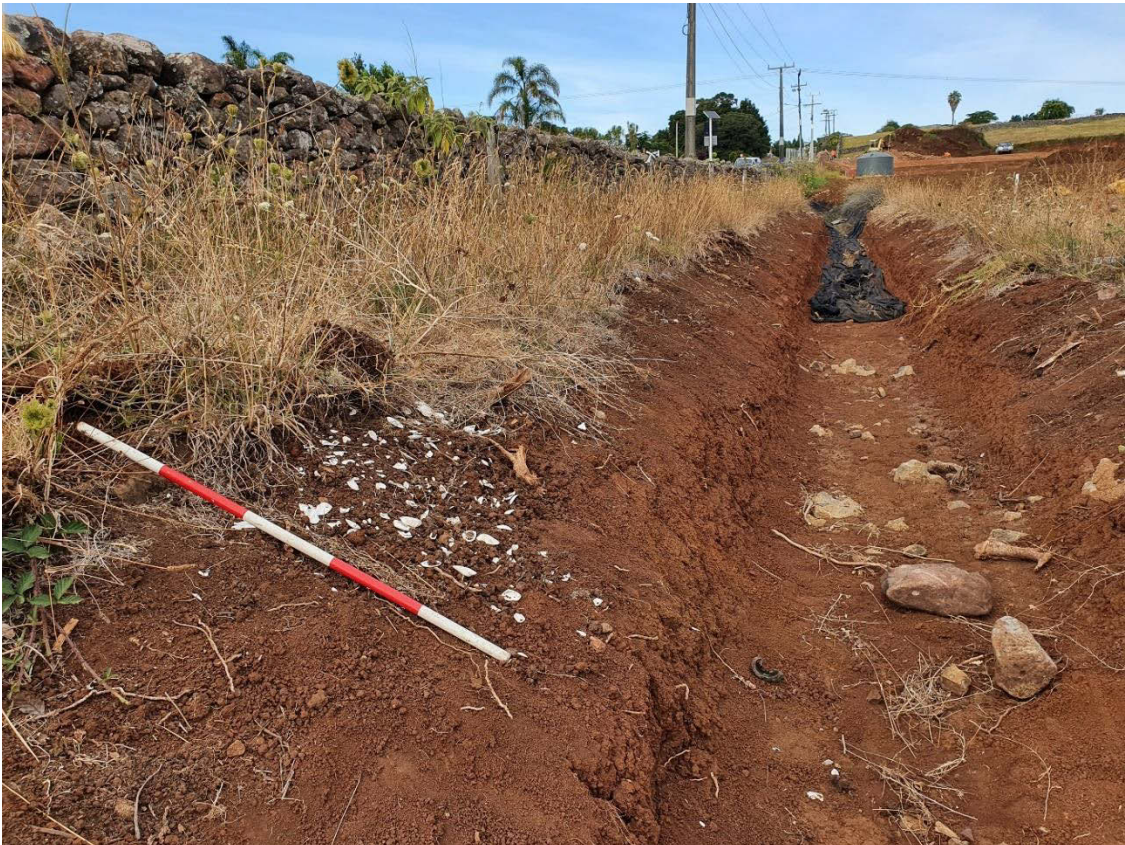
The midden inspected on 2 February comprised a 1 x 1m scatter of medium-sized tuatua in orange-red silty stony volcanic soil. There was no depth to the deposit, no sign of charcoal, fire-cracked rock or an associated occupation layer around the scatter on the surface or the adjacent trench and other exposed areas in the vicinity.

Figure 22: Shell exposed in trench, immediately north of existing 115 Three Mile Bush Road crossing.

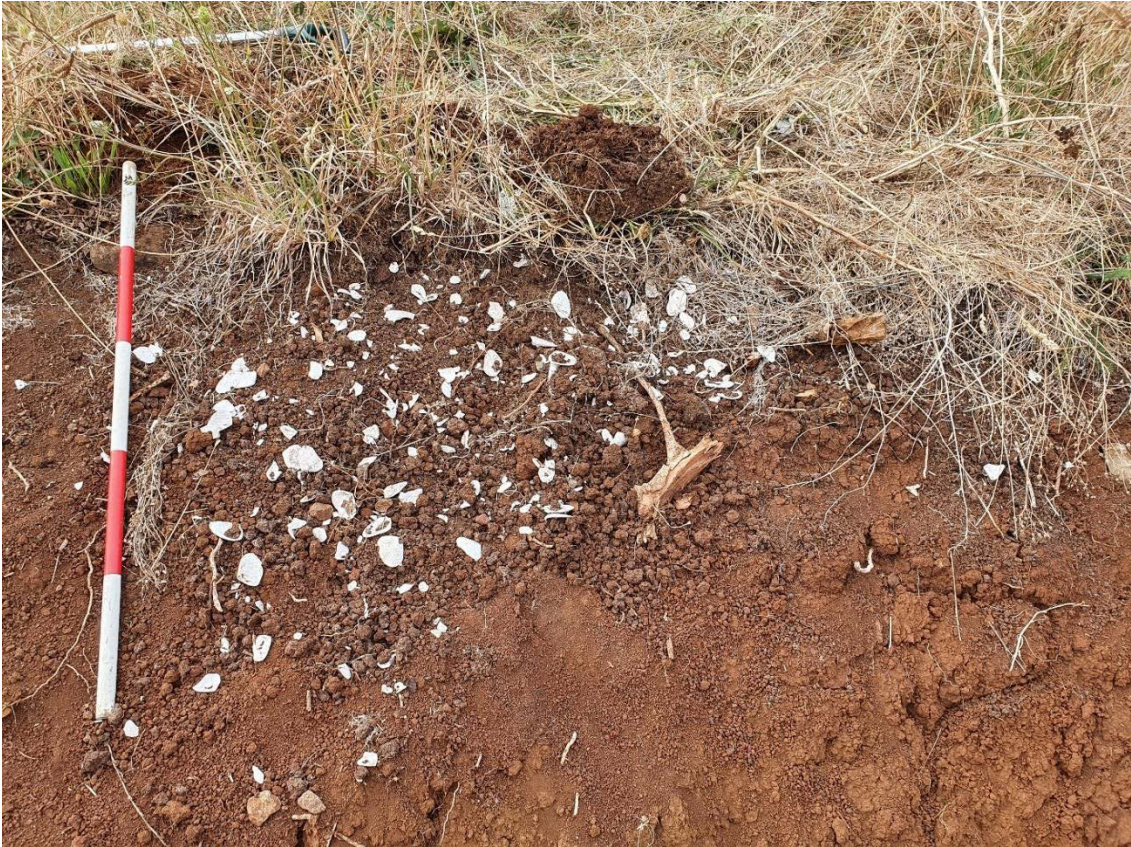
Figure 23; Detail of shell

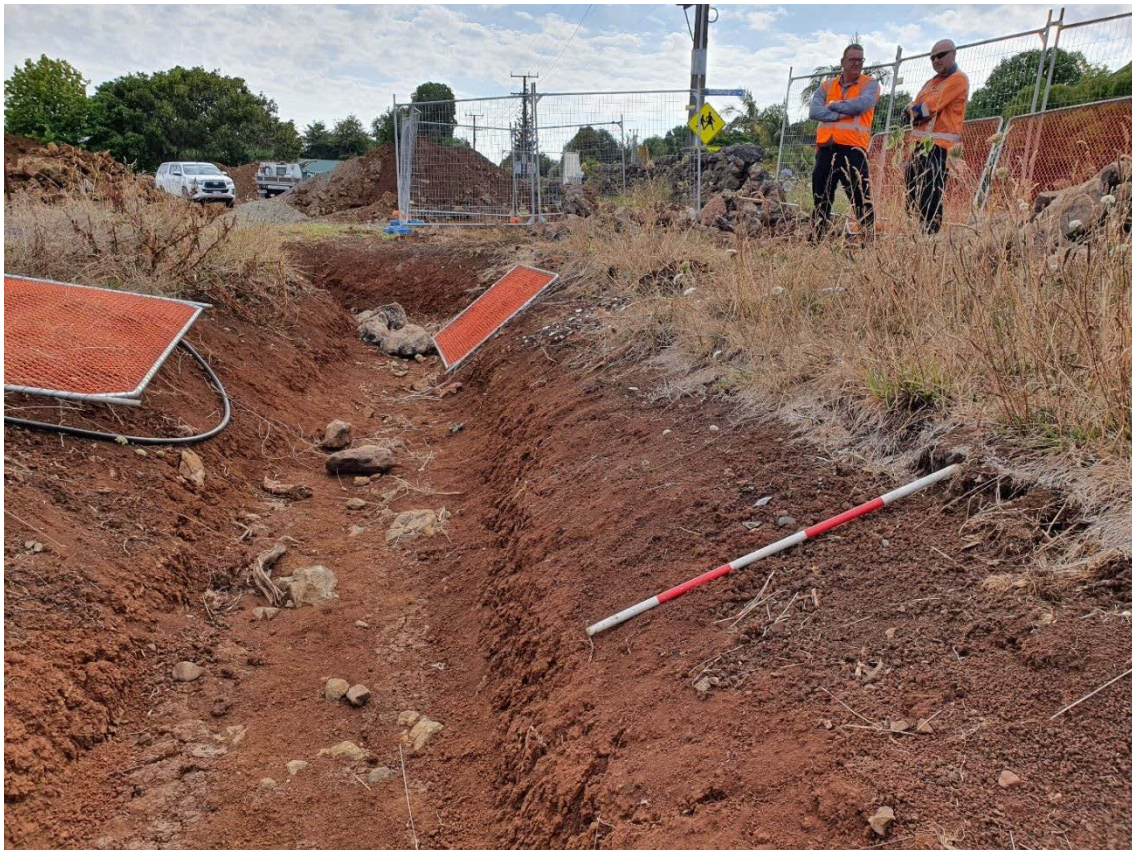
A broken, green bottle base fragment was noted lying in the base of the trench directly below the shell. Additional glass from two other bottles was noted on the upper edge of the trench cut, at the same level of shell, three metres to the west. The green glass base was from a thick-walled champagne style bottle with a pronounced kick-up, other fragments were from a thin-walled olive green bottle with a rounded shoulder, and a clear glass bottle. No other diagnostic information was available.

Figure 25: Scatter of green and clear bottle glass at same level as shell.

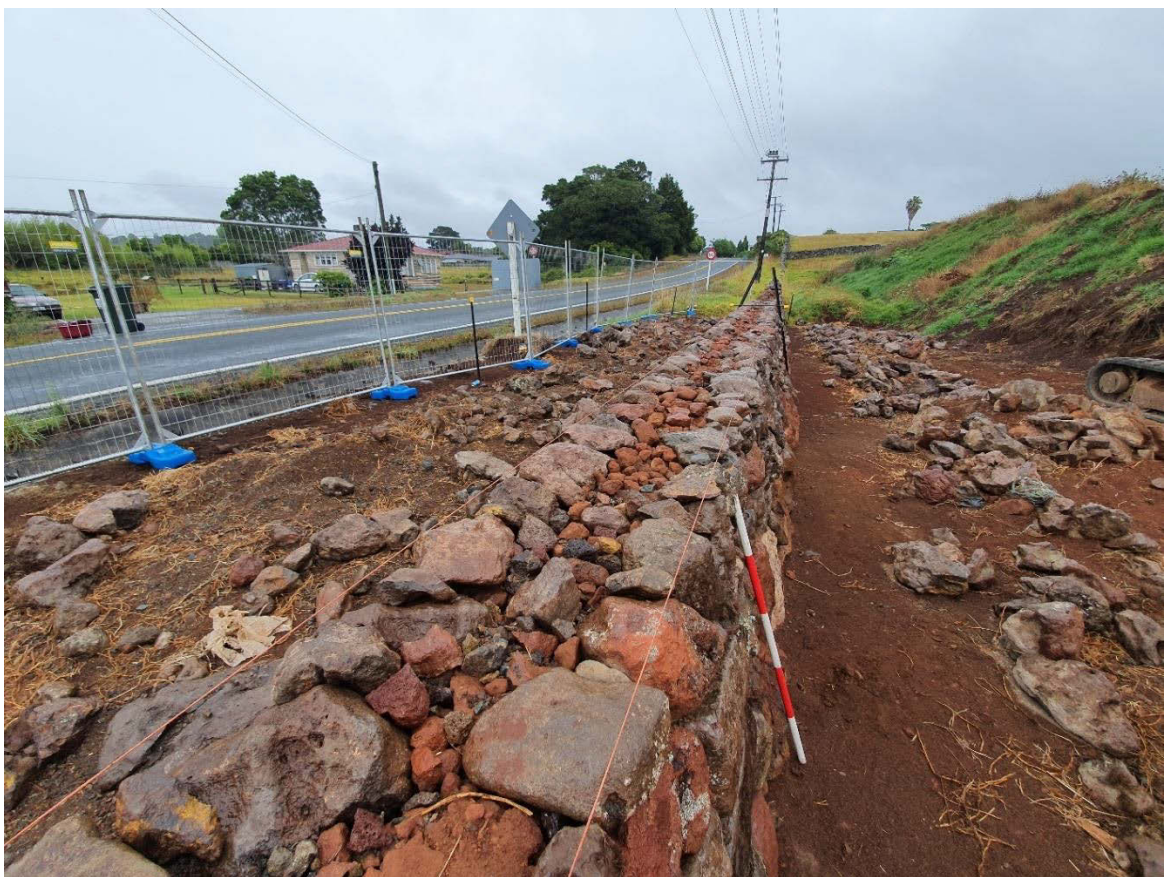
and excellent condition where it has been recently reconstructed. However the wall is typically 1-1.2m high, somewhat shorter than usual and suggestive of prior modification.

Figure 36: Reconstruction of stone wall.

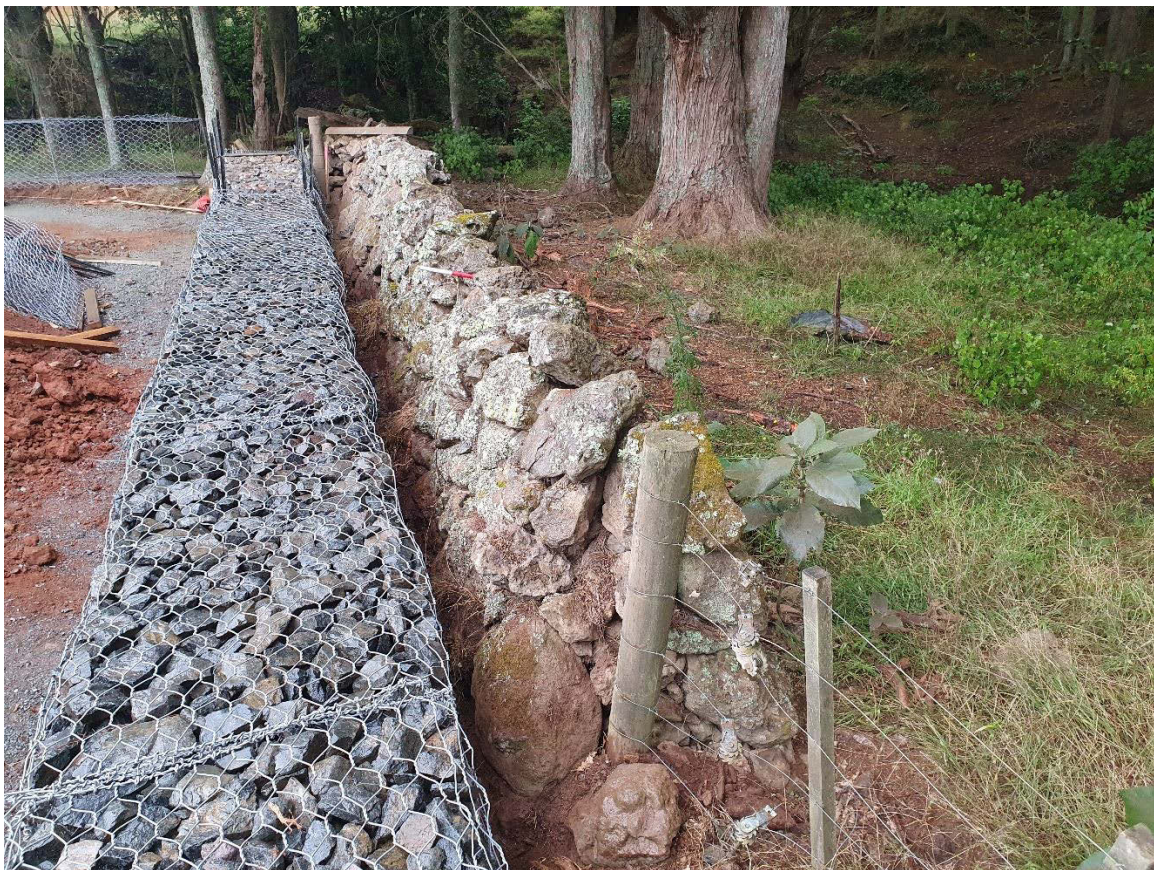
The rest of the property has been comprehensively recontoured, with a small area of unmodified stone wall and mature native trees remaining along the stream on the northern boundary.

Figure 42: Section of wall in fair condition along northern boundary.

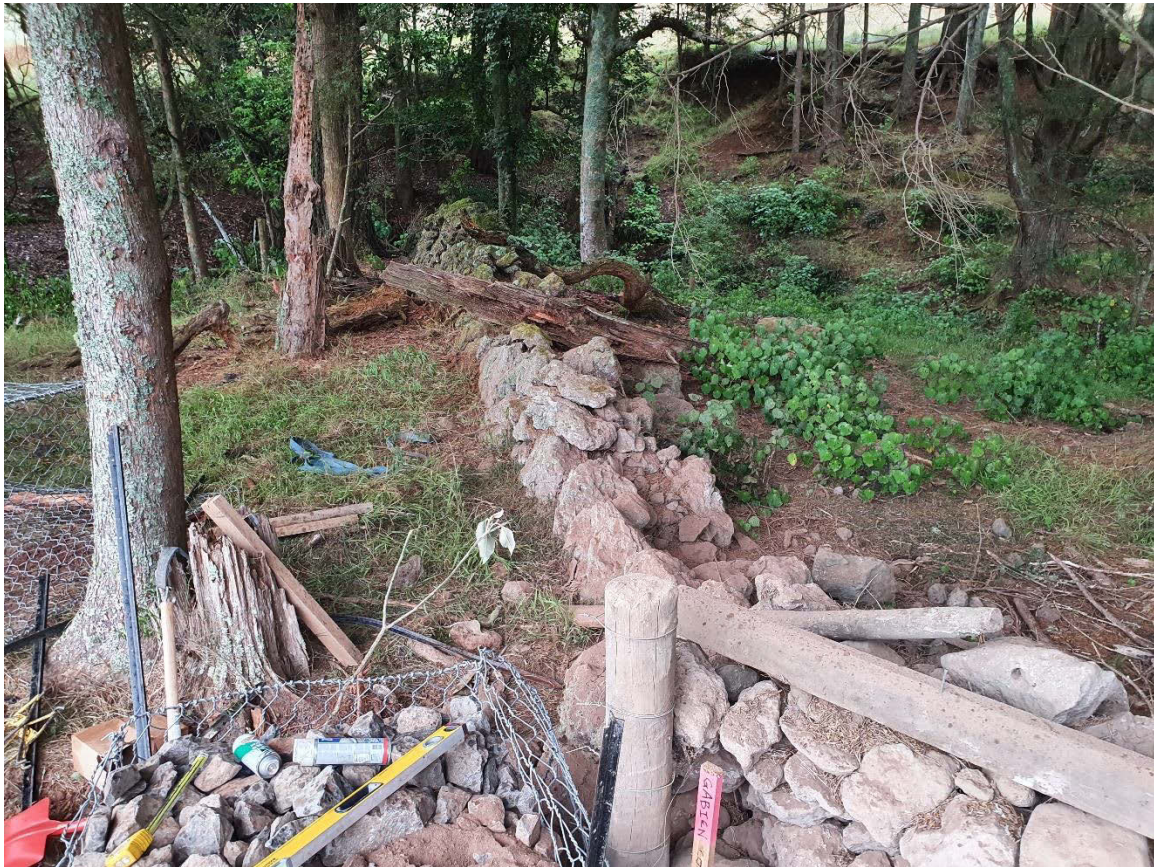
Figure 43: Section of stone wall in poor condition on northern boundary.

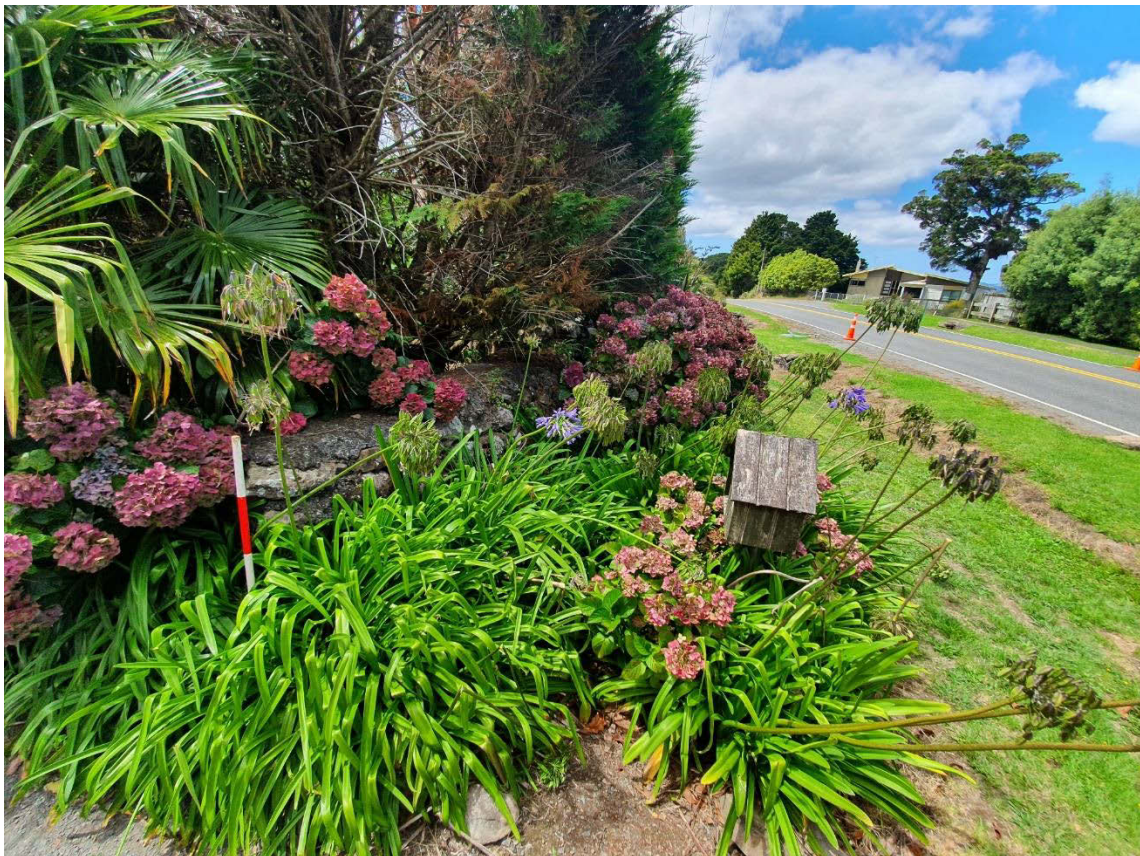
Figure 49: Wall at driveway crossing modified by lowering and chip seal coping.

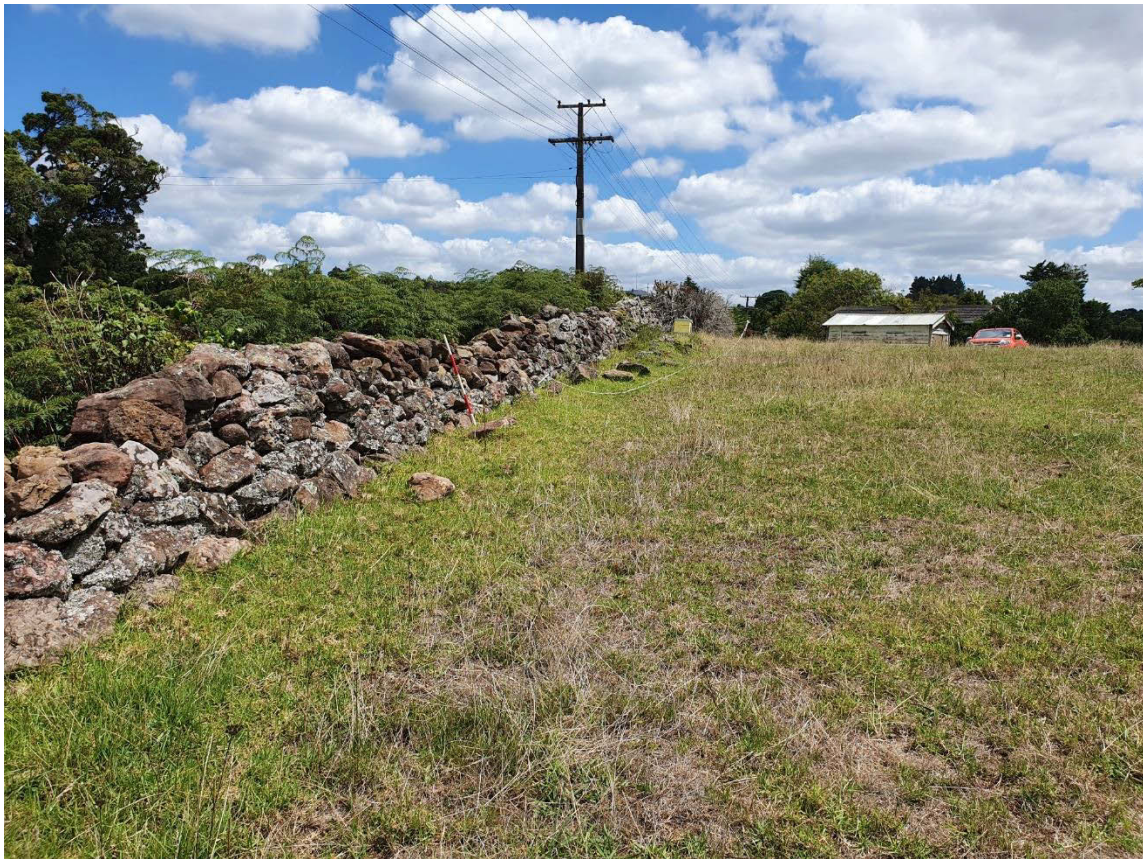
Approximately 175m of stone wall is present along the southern boundary/road frontage, with two crossings. The stone wall along the road frontage is in fair condition. The southern side is largely obscured by vegetation but the north side is clear of vegetation in parts. The coping rocks are mostly absent from along the wall, and the wall has been affected by general wear, stock rubbing, and tree growth. Some sections of wall have been repaired but in the absence of the coping stones to hold the wall together, will continue to fail over time.

Figure 50: Three Mile Bush Road boundary wall.

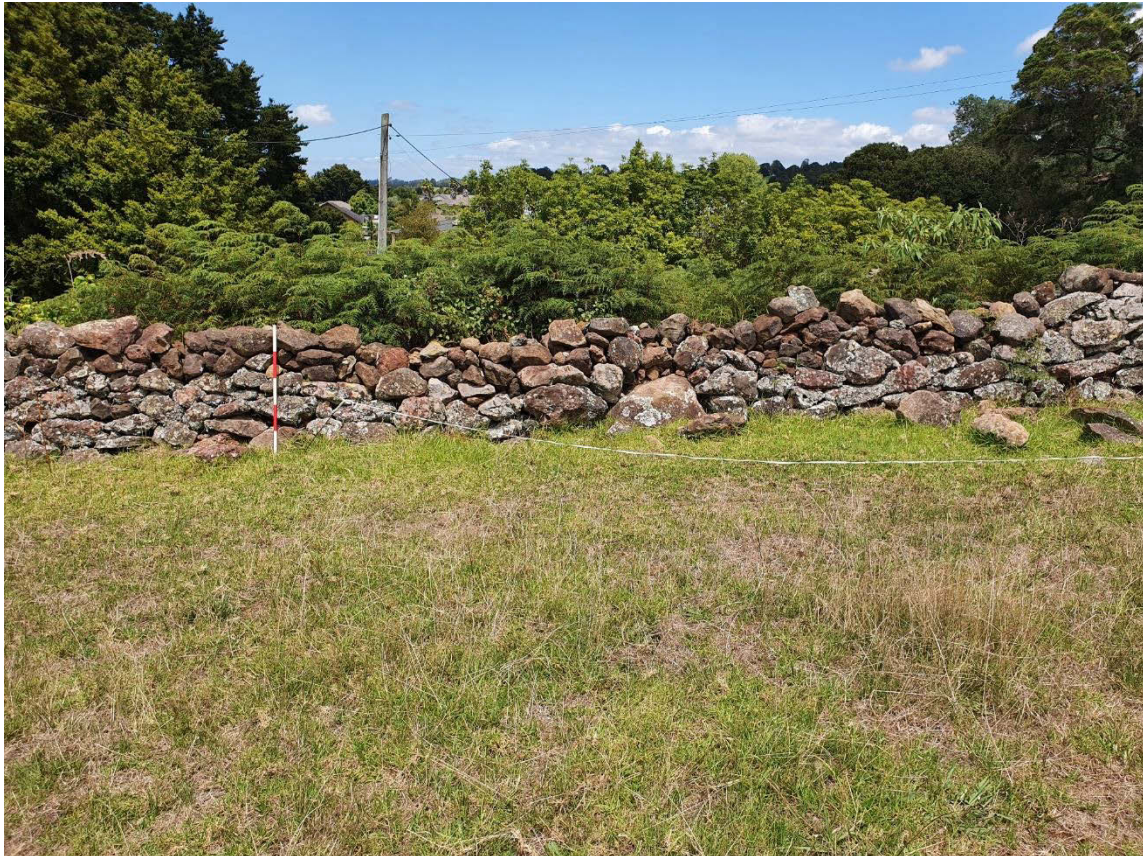
Figure 51; Poorly repaired section of Three Mile Bush Road boundary wall.

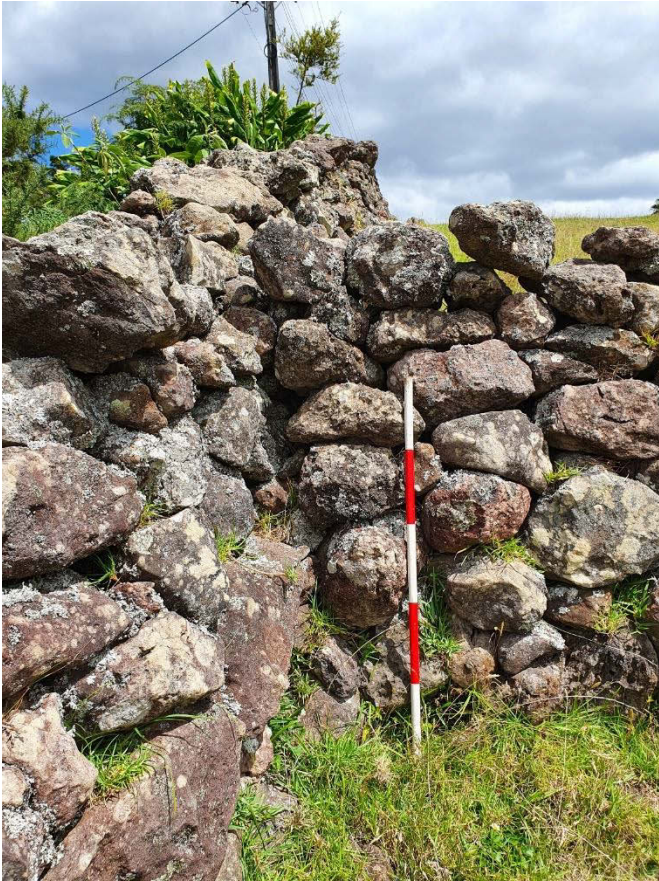
The internal stone wall is also only in fair condition. It is built up against the road boundary wall and does not appear to be keyed into the wall as might be expected if they were built at the same time. Most of the copping stones are absent, leading to the poor state of the wall. The wall is 1.0-1.4m over most of its length, but sections with copping still present are 1.4-1.6m high.

Figure 52; Internal wall built against Three Mile Bush Road boundary wall.

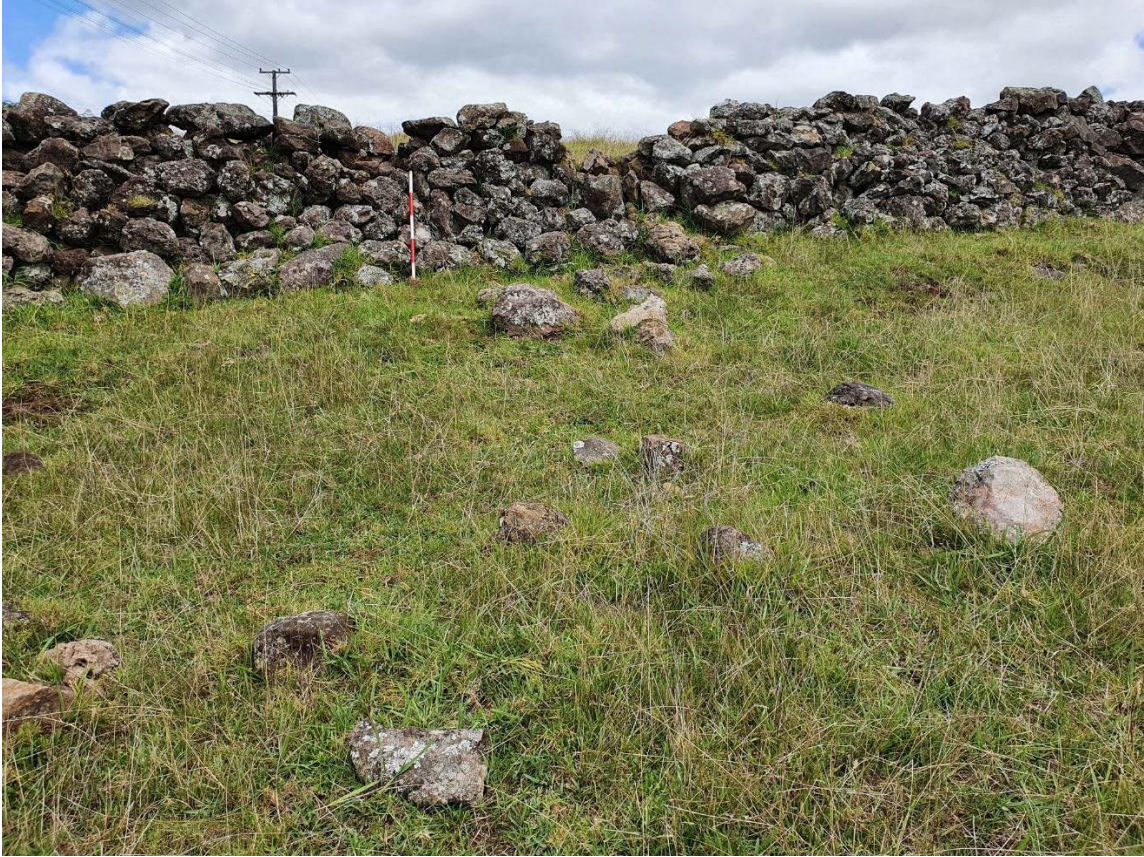
Figure 53: Section of wall in poor condition.

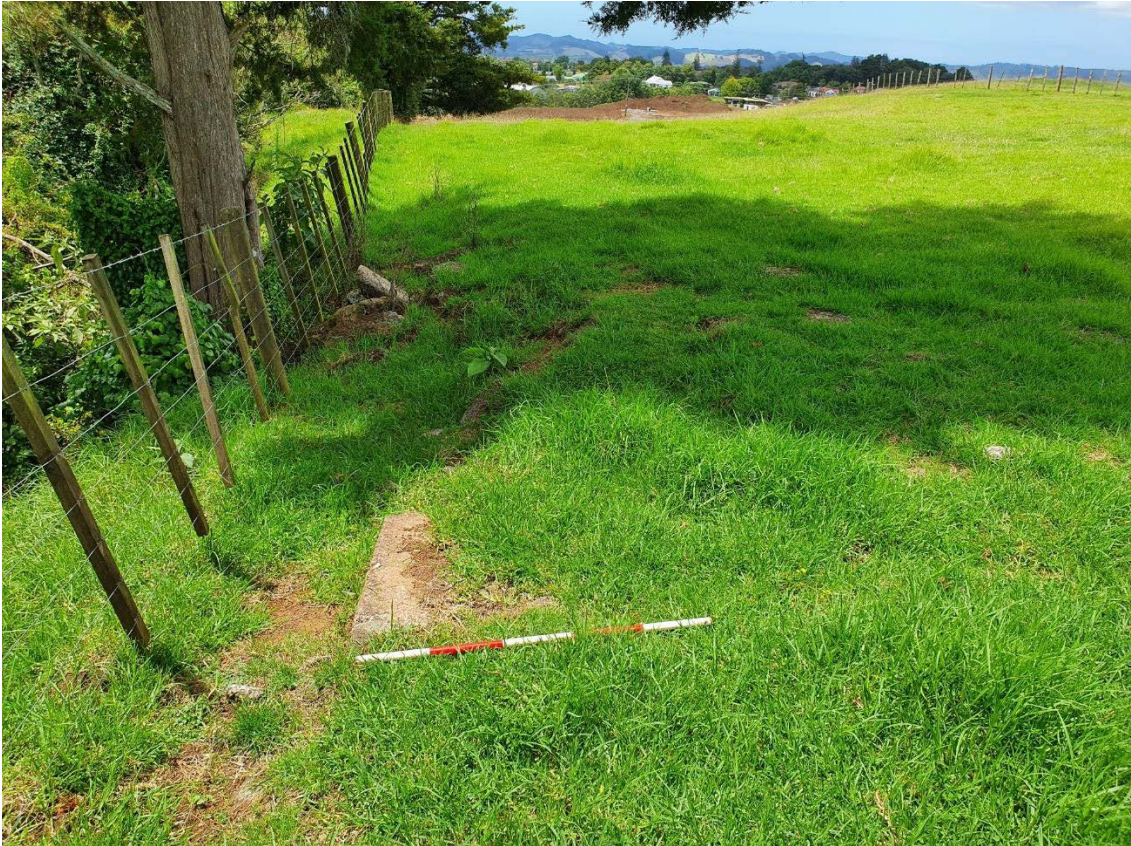
Figure 57: Concrete slabs and blocks pushed into small swale.

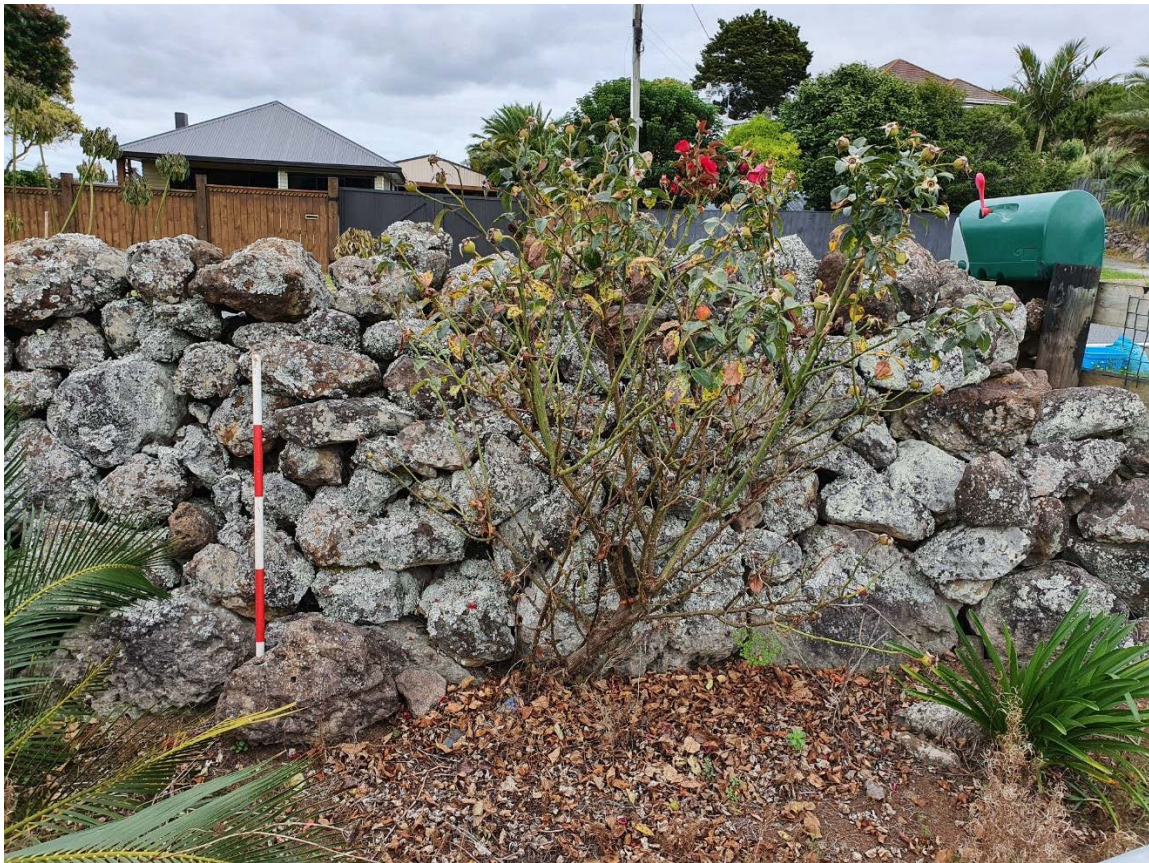
Approximately 10m of stone wall is present at the road crossing to Three Mile Bush Road, bisected by the road crossing/driveway. This wall is also in good condition and 1.2-1.4m high by 1.2m wide.

Figure 60: Detail of stone road boundary wall adjacent to road crossing.
