Geotechnical Report

GEOTECHNICAL INVESTIGATION REPORT
FOR
PROPOSED RESIDENTIAL DEVELOPMENT,
131 AND 189 THREE MILE BUSH ROAD, KAMO, WHANGAREI

Project Reference: 18733
24 June 2021

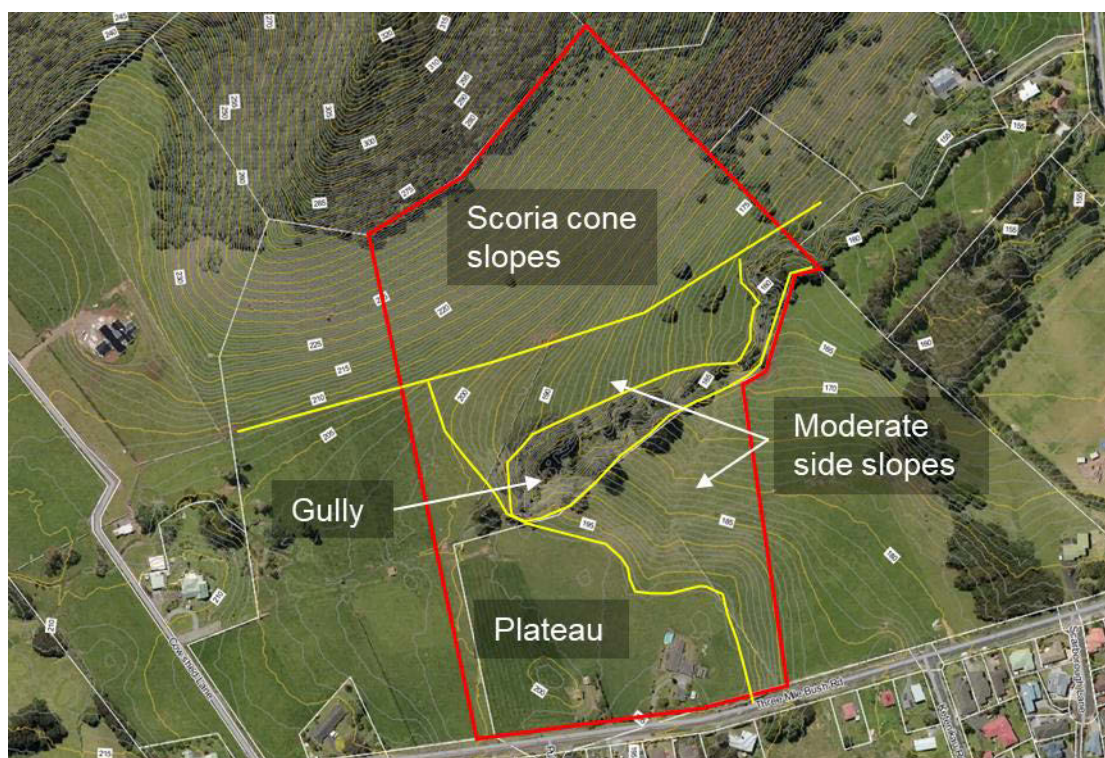
Figure 2: Plan of the site, showing general topographic areas. Site boundary shown in red.

The gully side slopes are very steep around the head at approximately 1V:1.5H (34°) and generally 1V:2H (27°) beyond this. The gully slopes present no signs of significant active or recent instability, and it appears from the topography of the feature that it has been formed through steady erosion rather than periodic regression through instability. However, some evidence of shallow creep type movement was noted on the southern side of the gully, where the fence appears to have been gradually undermined.

Several exposures of large basalt boulders are noted around the crest at the western end of the gully. Several areas of tephra soils are exposures through the mid-section of the steeper slopes. The gully floor is covered by cobble to boulder sizes clasts of loose basalt, with some possibly in situ basalt at the base of the gully head.

The gully is fed by overland flows through formed drains, originating to the west of the site, and sheet flows from the slopes to the north and south, forming a headwater of the Waitaua Stream. It is likely that groundwater seepage occurs at the head of the gully where it is most deeply incised. It appears to only flow during wet winter conditions and, during and immediately after heavy rainfall.

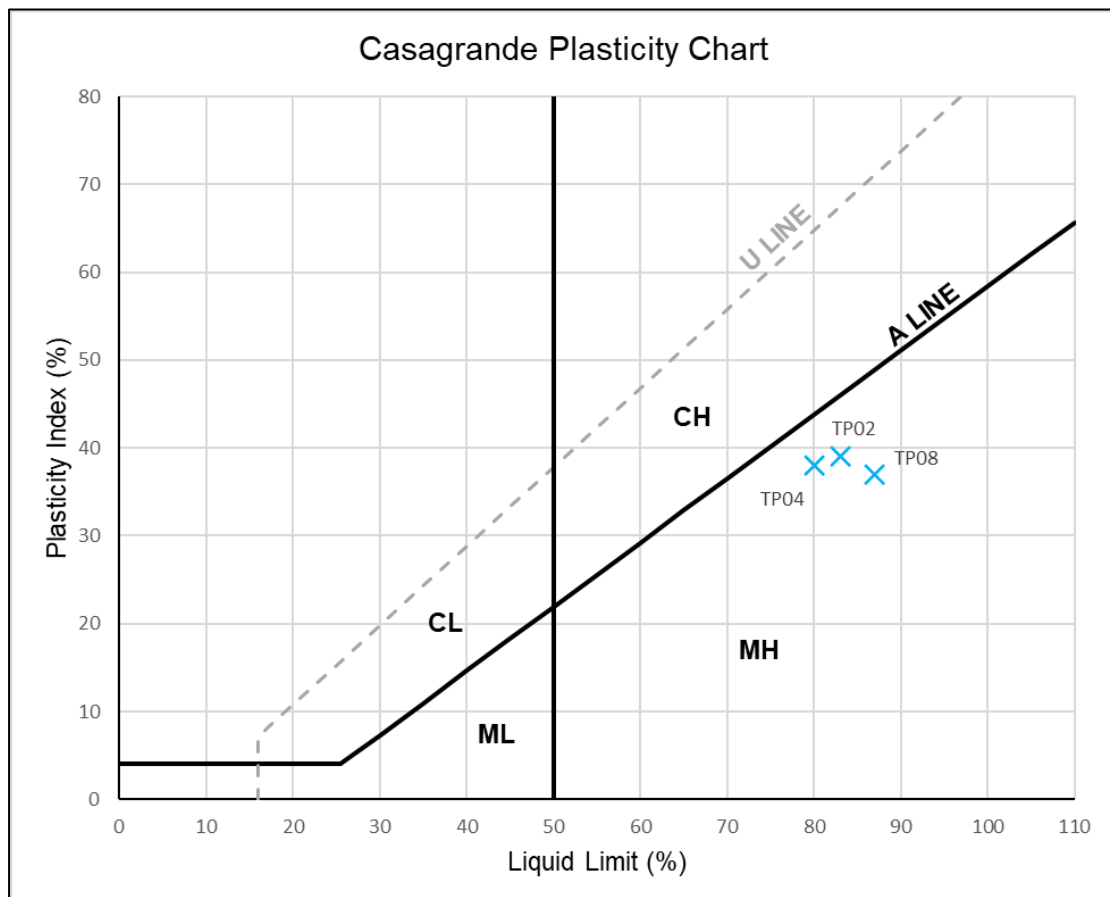
Figure 6: Test results shown against Casagrande plasticity chart for USCS classification.

The soils appear to be generally silt dominated from field assessment and fall below the Casagrande 'A-line' as shown on Figure 5. The soils plot as very highly plastic on the basis on liquid limit ($70\% < LL < 90\%$).

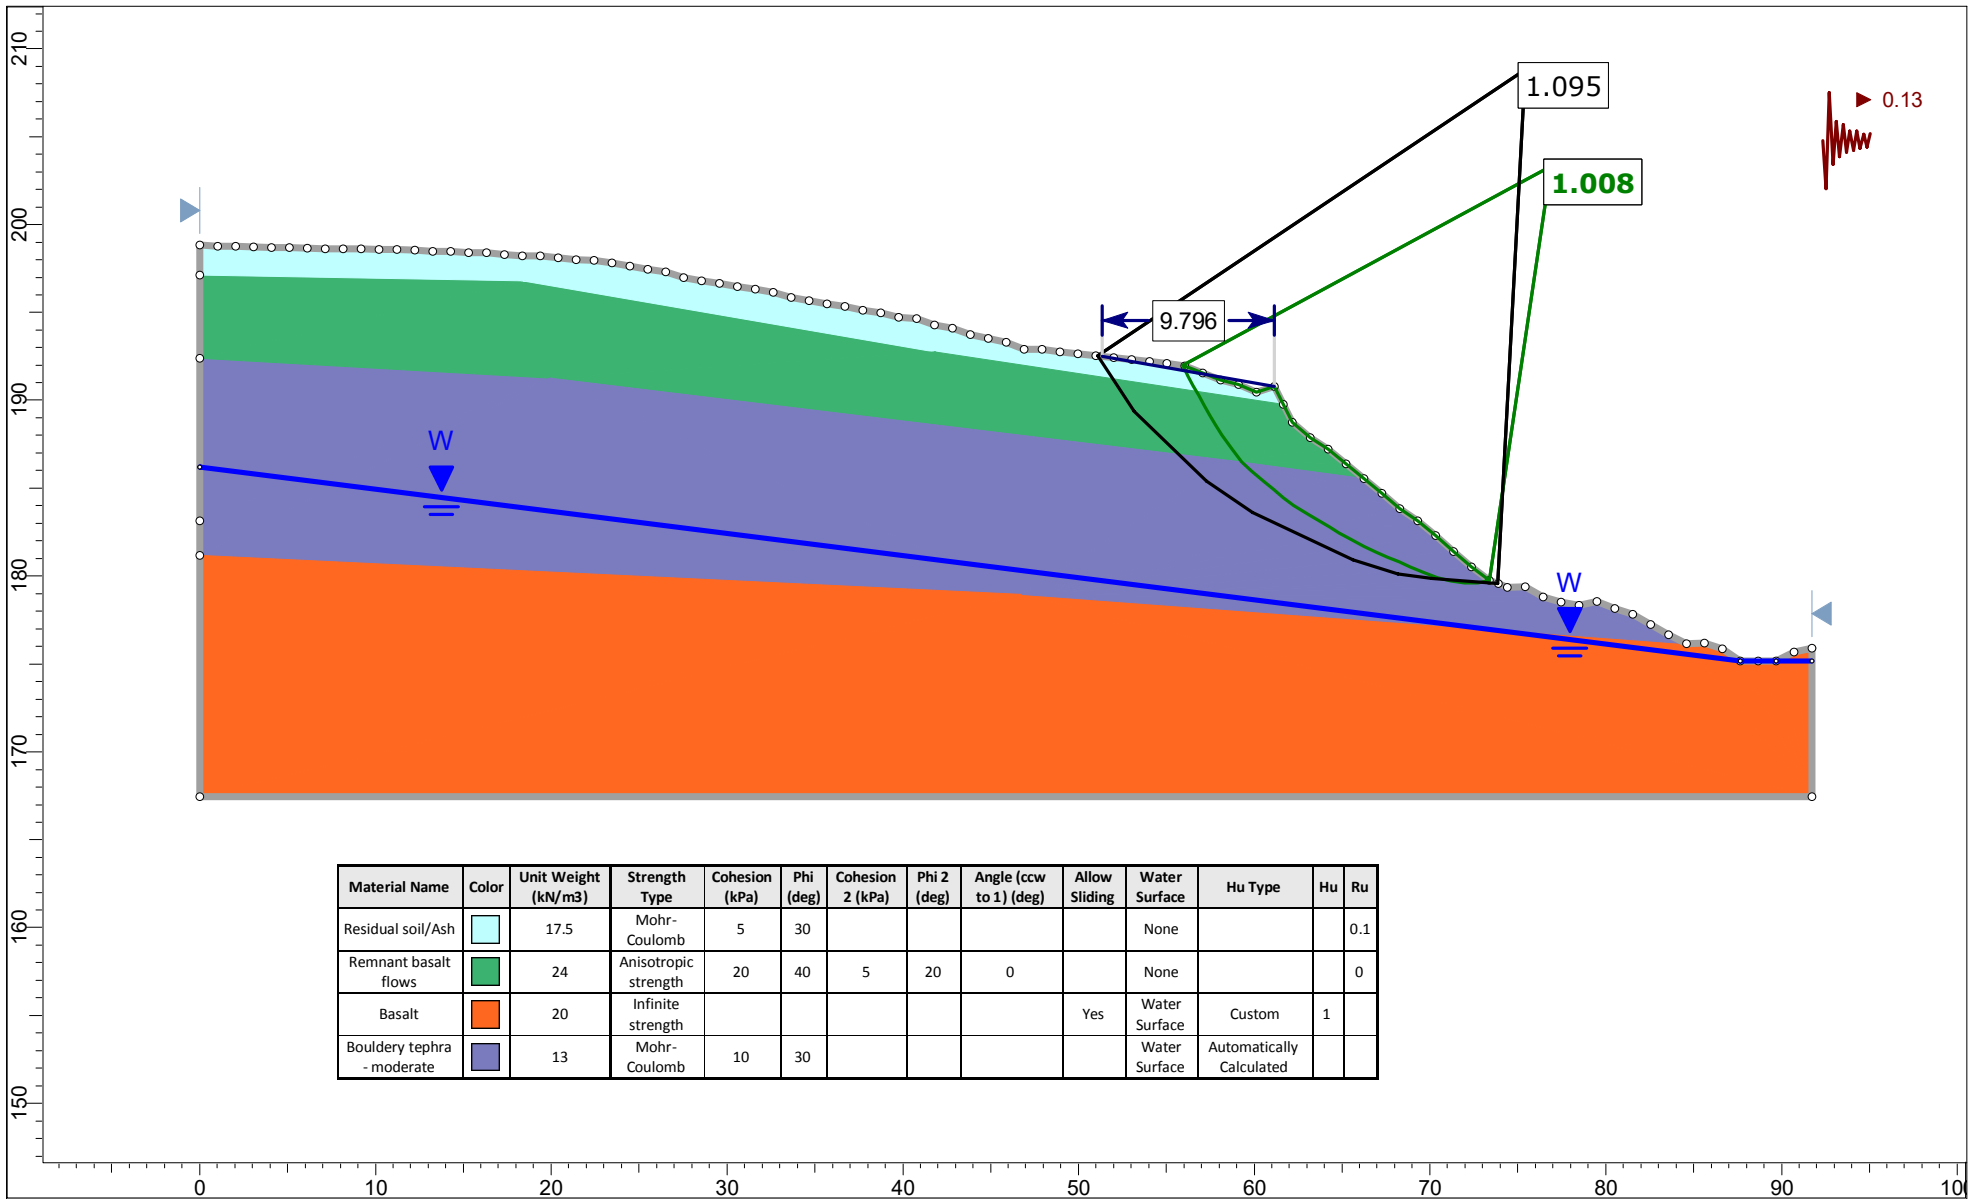
Project		131 and 189 Three Mile Bush Road	
Analysis Description		CS-2 - Extreme groundwater	
Drawn By	FWH	Scale	1:430
Date		22/06/2021	
Company		LDE Ltd	
File Name		18733.slmd

To assess the stability hazard of the gully feature, numerical slope stability analysis has been carried out for a critical side slope section (CS-2), on the southern side of the gully head. Back analysis was used to calibrate modelled groundwater conditions and material strength parameters, using an assumed minimum factor of safety of just above 1.0 under extreme conditions.

The remnant basalt flow was modelled using an anisotropic strength, with the design parameters used for horizontal strength and reduced strength in line with a weak soil used for vertical failure. This reflects the expected nature of failures through this unit, which would follow vertical joints which are expected to be relatively continuous through the unit. This is a conservative assumption given the basalt, where exposed, was not pervasively jointed.

Scenario	Minimum FoS ³	Setback required
Normal (design conditions)	1.5	14m
Extreme groundwater	1.3	8m
Seismic (500-year/ULS)	1.1	10m

The northern side of the gully is generally less steep with the slope rounding over at the crest. A nominal 7m setback from the crest is recommended across the upper slopes without specific assessment.
